Home Inspection Report

Address Not Available, Lynnwood, Washington 98087

Wednesday, December 30, 2020

1230202001

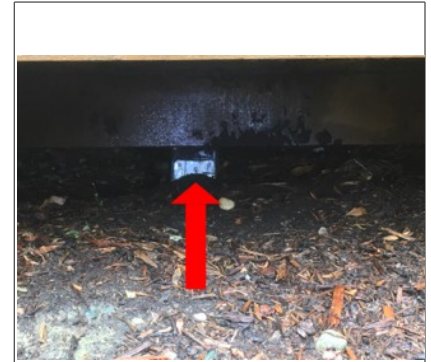
Deck post and joist bracket in contact with soil. Recommended remove soil from around post.

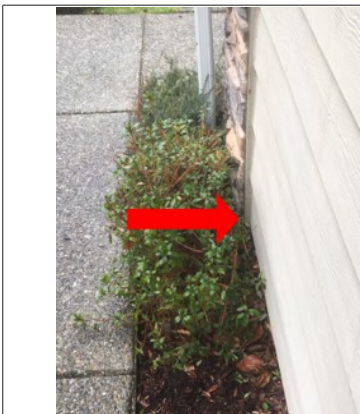
Ground cover in contact with siding recommend trimming vegetation.

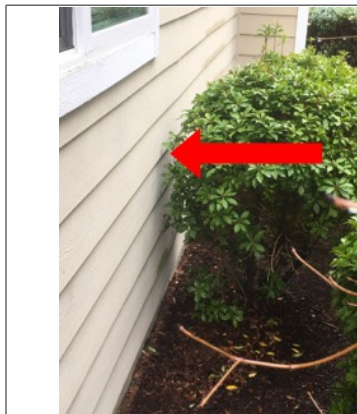
Ground cover in contact with siding recommend trimming vegetation.

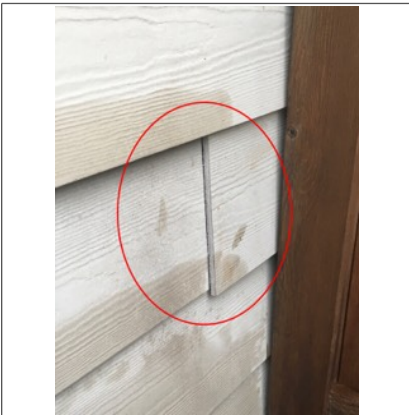
There are several loose boards on the back of the residence.

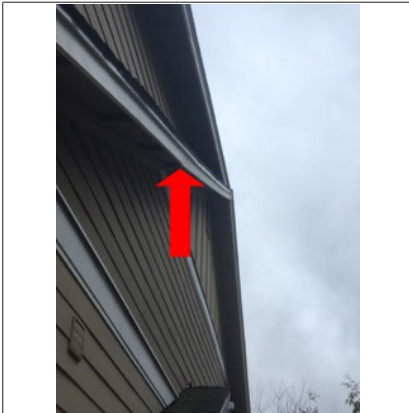
Fascia board on side of building is twisting/separating from supports. Recommend further evaluation/repair by licensed roofing contractor.

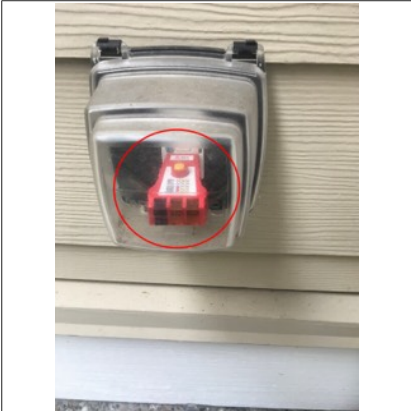
Exterior GCFI outlet not functional and could not be tested. Recommend further evaluation/repair by qualified electrical contractor.

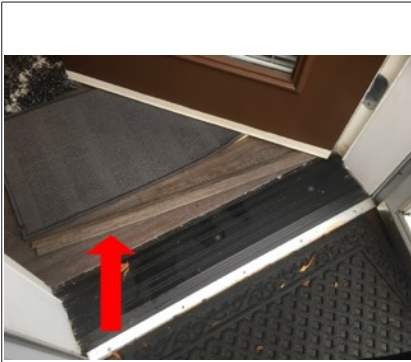
Back door threshold is loose and not properly installed. Recommend further evaluation/repair by licensed contractor.

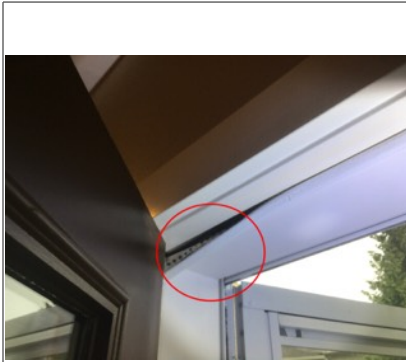
Weather stripping loose on back door (to deck). Recommend further evaluation/repair by licensed contractor.

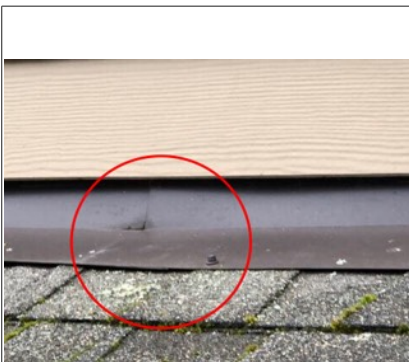
Roof flashing fasteners should be sealed/chalked. Recommend further evaluation/repair by licensed roofing contractor.

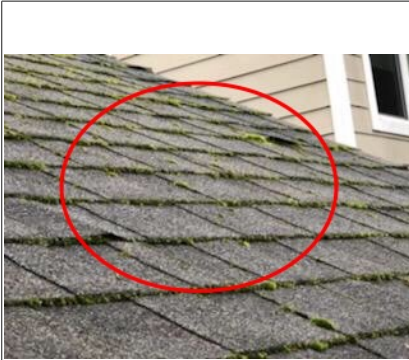
Comments There are a few roofing tiles that are slightly curling. Due to the weather conditions and the moss build-up on the roofing material, I could not access the roof for a full evaluation. Recommend further evaluation by licensed roofing contractor.

Image of moss build-up on asphalt shingles. Recommend cleaning by licensed roofing contractor.

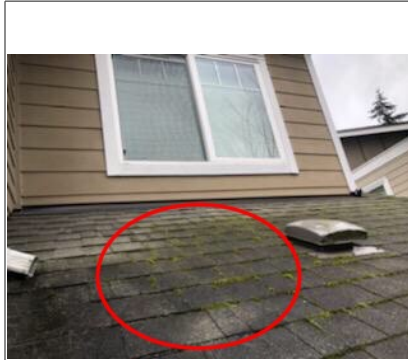
Image of moss build-up on asphalt shingles. Recommend cleaning by licensed roofing contractor.

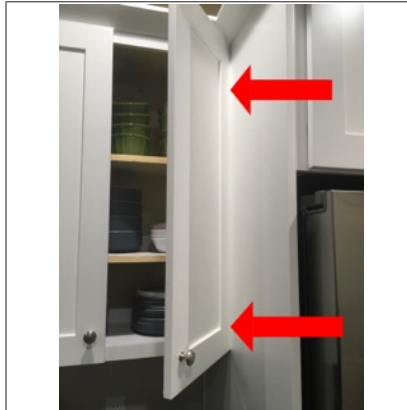
Cabinet is binding on right side against cabinet wall. Recommend adjusting cabinet door or repair by licensed contractor.

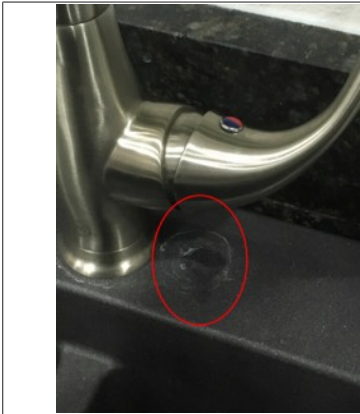
Visible water leak coming front handle on sink. There was a small circle on counter under handle indicating ongoing leak. Recommend further evaluation or repair by licensed plumbing contractor.

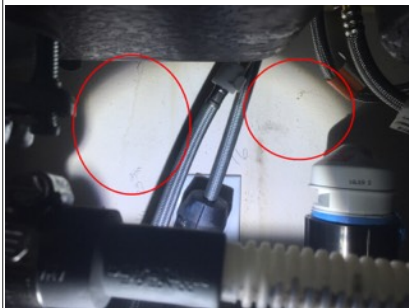
View of stains on back of cabinet/wall under kitchen sink. There was no visible leak. Stains could be from damaged grout/sealing of backsplash and counter.

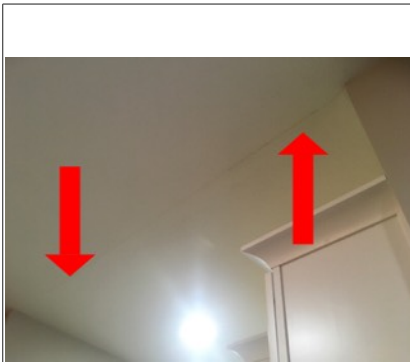
Crack on ceiling near entry to kitchen. This crack does not appear to be structural.

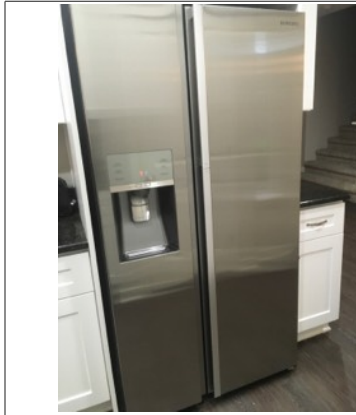
Water and ice could not be tested. There is a red light on the front of the refrigerator indicating the filter needs to be changed. Recommend further evaluation/repair by licensed repair company.

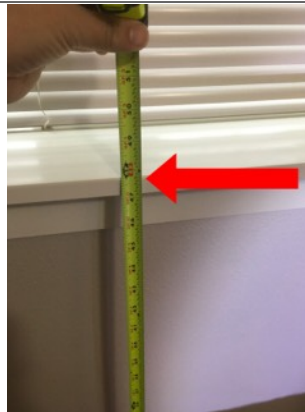
Master bedroom window is 47 inches above floor and for safe egress should be 44 inches. This could potentially be a safety issue and recommend further evaluation by licensed contractor.

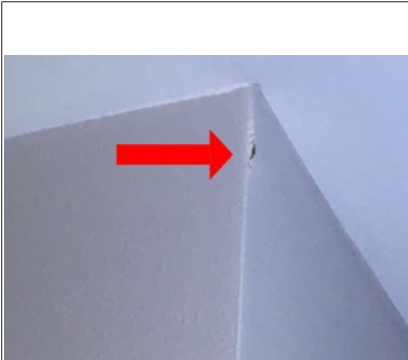
Damage to wall surface near sealing next to window. There does not appear to be caused by moisture penetration.

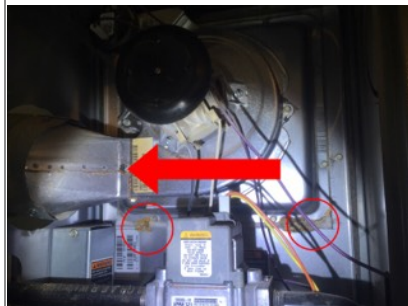
There is evidence of condensation inside furnace around vent and heat exchanger. Recommend further evaluation by licensed HVAC contractor.

Image of condensation buildup inside HVAC unit. Recommend repair/evaluation by licensed HVAC contractor.

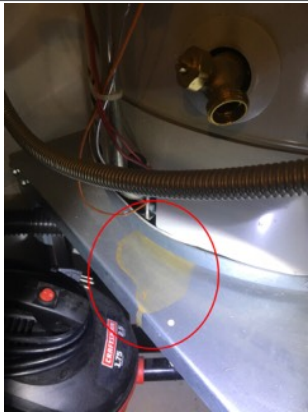
There is rust located on the bottom of the water hot tank, This unit is approaching its expected life expectancy and further evaluation should be completed by licensed plumbing contractor.

The water heater is approaching its expected useful life expectancy of 15 years and may need to be replaced in the future. I recommend further evaluation by a licensed plumbing contractor.

Image of rust from moisture coming from bottom of hot water tank. Recommend further evaluation/repair by licensed plumbing contractor.

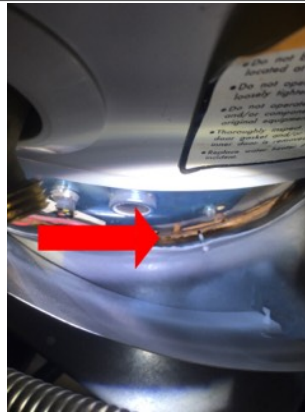
Image of rust on the bottom of the hot water tank. Recommend further evaluation/repair by licensed plumbing contractor.

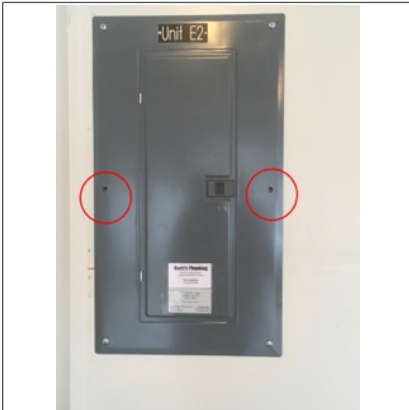
Missing two dead-front panel screws. Further evaluation/repair by licensed electrical contractor.

Missing two dead front panel screws. Further evaluation/repair by licensed electrical contractor.
