# Home Inspection Report

In, Federal Way, Washington 98003

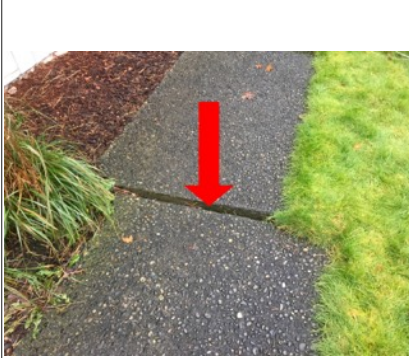
There are several areas of the service walk that are uneven and could present a SAFETY ISSUE. Recommend further evaluation/repair by licensed contractor.

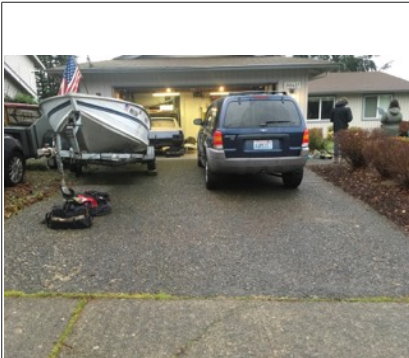
View of driveway with typical cracks and wear for age of concrete.

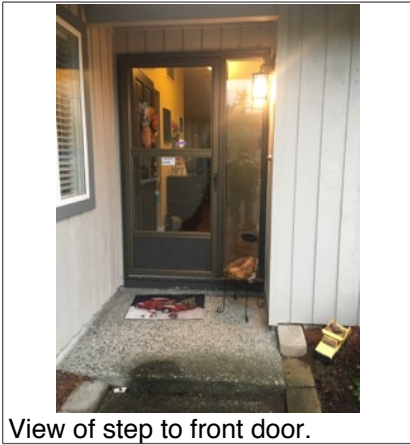
View of step to front door.

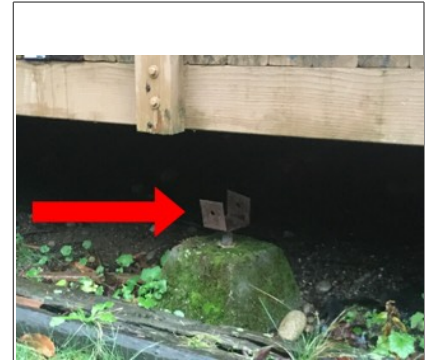
There are several discarded concrete bases under the deck structure. Due to limited access during the inspection, recommend further evaluation/repair by licensed contractor.

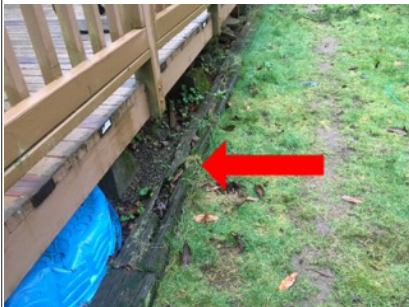
There is conductive material stored below the deck structure that could attract wood destroying insects. Recommend removal of this wood by licensed contractor.

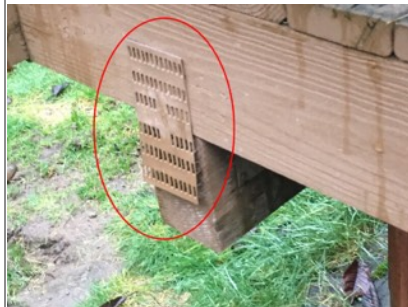
Gusset plates are not needed on the ends of the beam and rim joist connection.

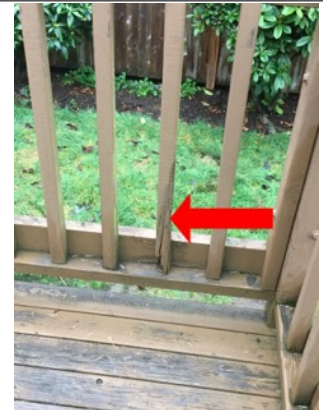
There are several damaged balusters and railing that could be a SAFETY ISSUE. Recommend further evaluation/repair by licensed contractor.

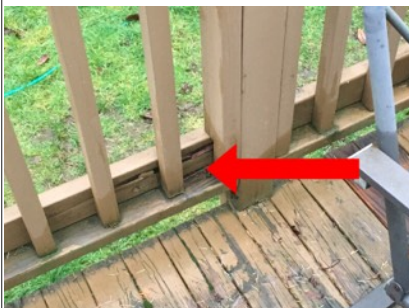
There are several damaged balusters and railing that could be a SAFETY ISSUE. Recommend further evaluation/repair by licensed contractor.

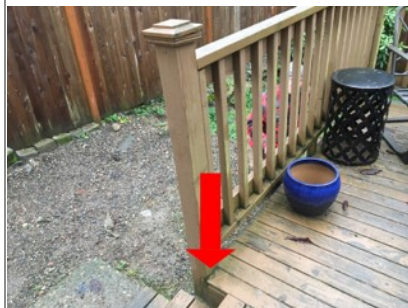
The railing post by the deck stairs is loose and could be a SAFETY ISSUE. Recommend further evaluation/repair by licensed contractor.

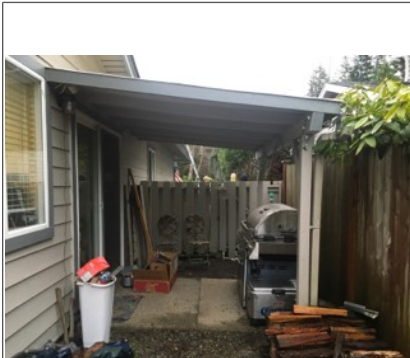
View of porch cover.

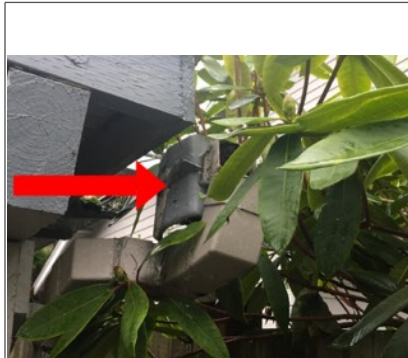
Gutter system has detached from the structure. Recommend further evaluation/repair by licensed contractor.

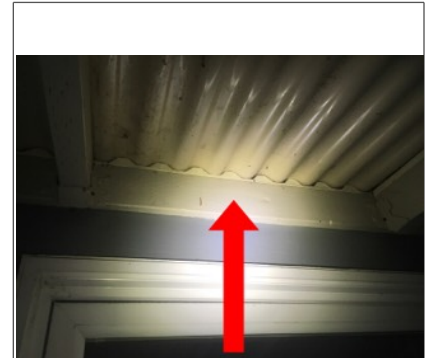
Patio cover should be attached to the structure with lag bolts or screws. Recommend further evaluation/repair by licensed contractor.

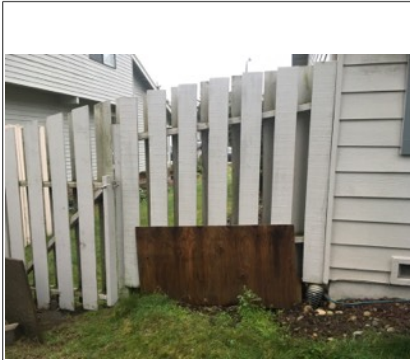
View of fence attached to structure

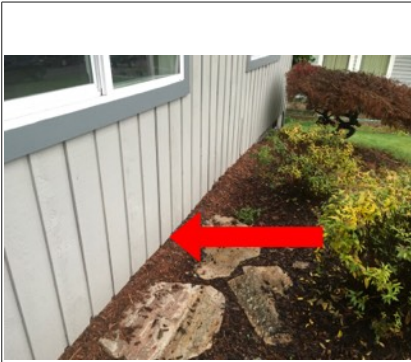
Landscaping should not directly touch siding. Recommend further evaluation/repair by licensed contractor.

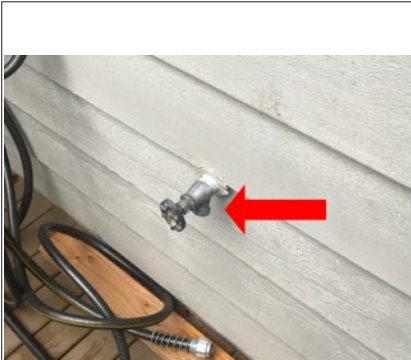
Hose bibs do not have anti-siphon device installed. Recommend further evaluation/repair by licensed plumbing contractor.

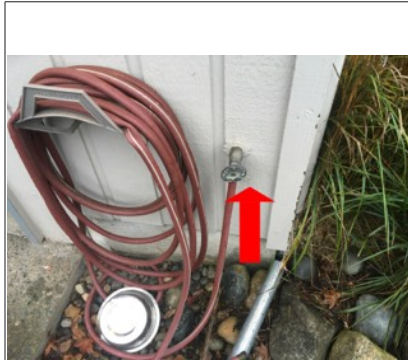
Hose bibs do not have anti-siphon device installed. Recommend further evaluation/repair by licensed plumbing contractor.

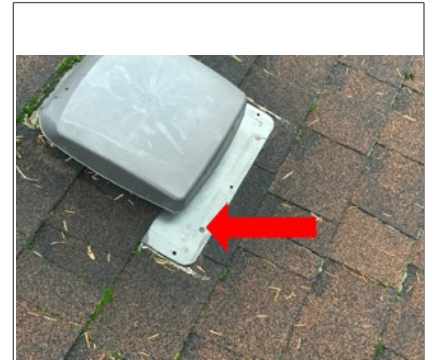
Nail heads should be sealed if installed through asphalt singles. Recommend further evaluation/repair by licensed roofing contractor.

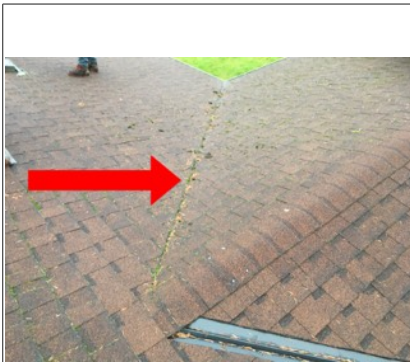
Closed valley that has moss and debris build-up along the valley. Recommend further evaluation/repair by licensed roofing contractor.

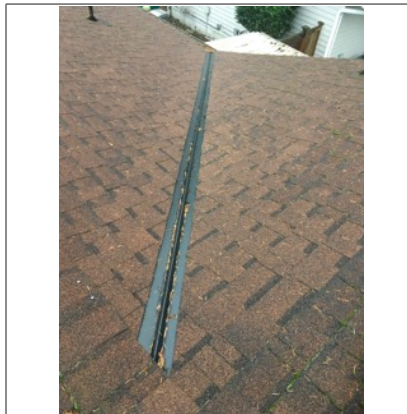
View of open valley.

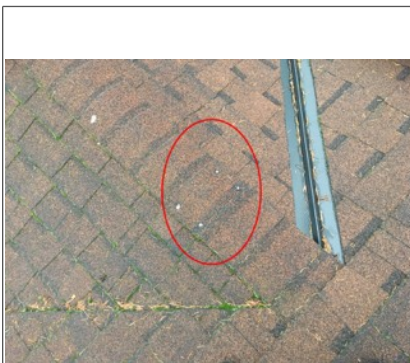
It appear that single repair was improperly completed. Nail holes should be sealed. Recommend further evaluation/repair by licensed roofing contractor.

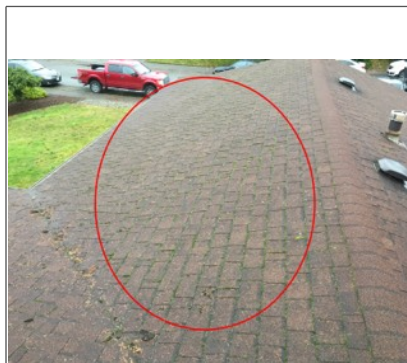
Large portion of roof surface has moss build-up. Recommend further evaluation/repair by licensed roofing contractor.

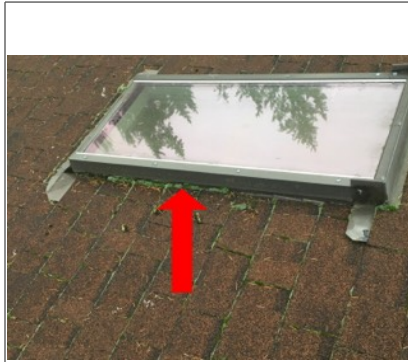
There is moss and debris build-up along flashing. Recommend further evaluation/repair by licensed roofing contractor.

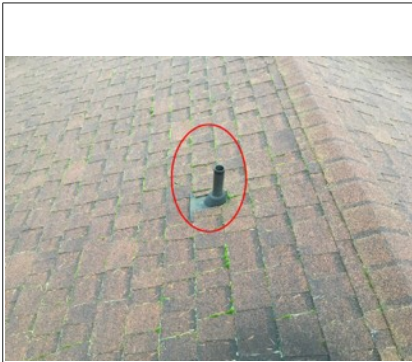
View of plumbing vents.

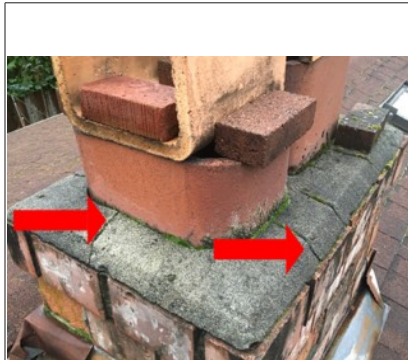
Chimney cap is cracked and could be allowing water penetration into flue. Recommend further evaluation/repair by licensed chimney specialist.

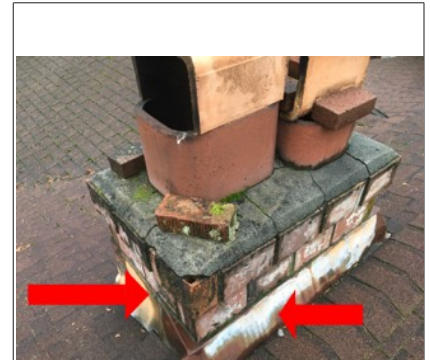
Chimney flashing is rusted and pitted. Recommend further evaluation/repair by licensed chimney specialist.

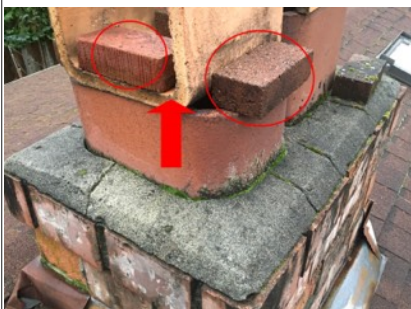
Loose bricks are being used as a rain shield for the chimney flue. This is a SAFETY ISSUE due to restricted airflow from the chimney and potential falling hazard from unsecured bricks. Recommend further evaluation/repair by licensed chimney specialist.

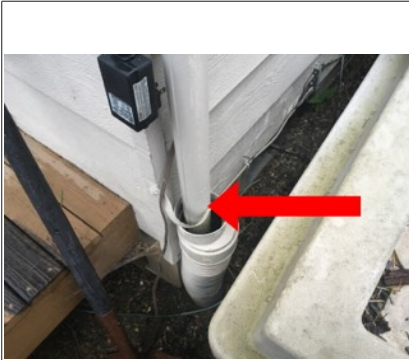
Loose drain pipe bracket.

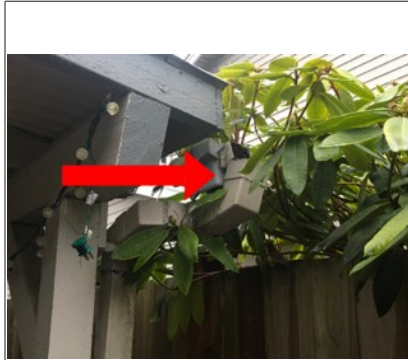
Gutter detached from structure. Recommend further evaluation from licensed roofing contractor.

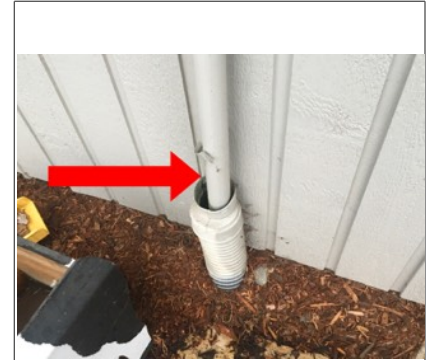
Loose drain pipe bracket.

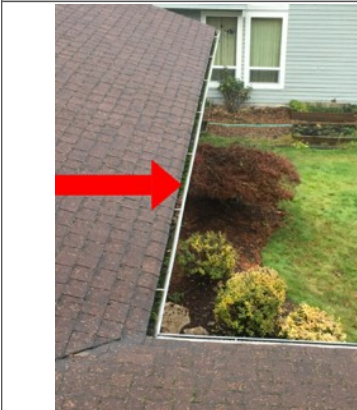
Gutters are full of debris and need to be cleaned. Recommend further evaluation by licensed contractor.

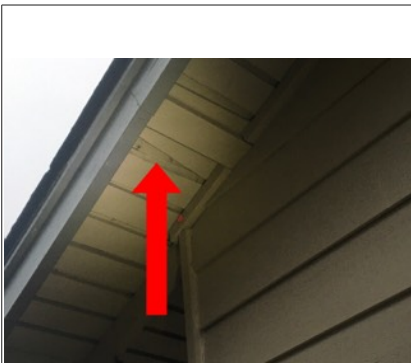
Damaged soffit board. Recommend further evaluation by licensed contractor.

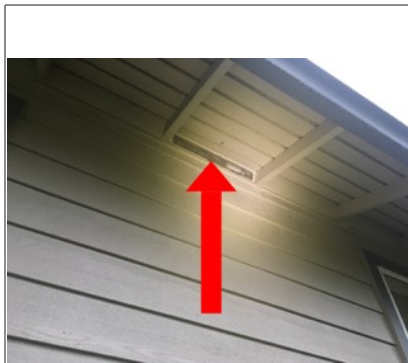
Soffit vent has hole in mesh screen. Recommend further evaluation/repair by licensed contractor.

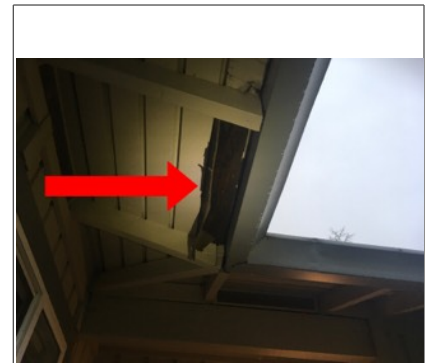
There appears to be moisture penetration into the soffit and fascia boards. Recommend further evaluation/repair by licensed contractor.

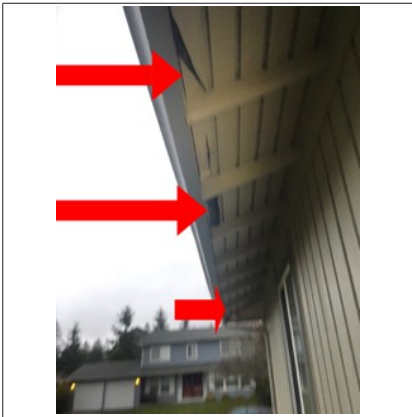
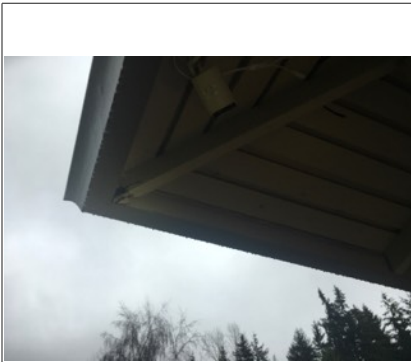
There appears to be moisture penetration into the soffit and fascia boards. Recommend further evaluation/repair by licensed contractor.

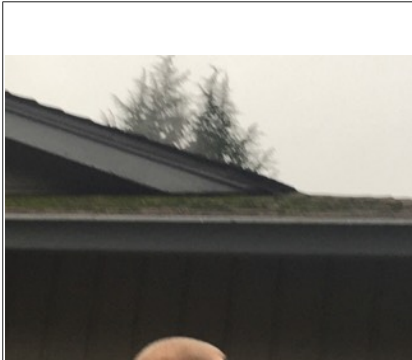
View of fascia board

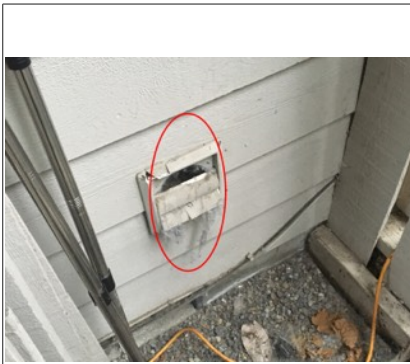
There is damage to dryer vent cover. Recommend further evaluation/repair by licensed contractor.

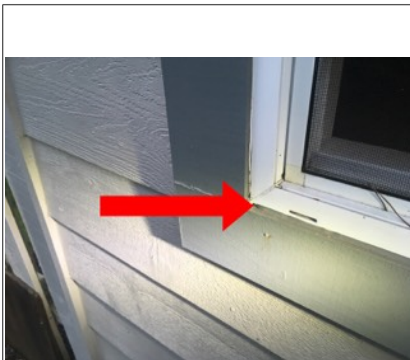
Recommend caulking around windows, doors, corners, utility penetrations.

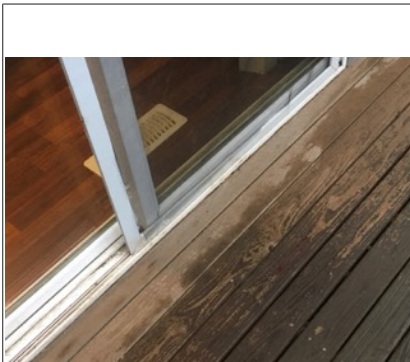
Some screens are torn recommend repair

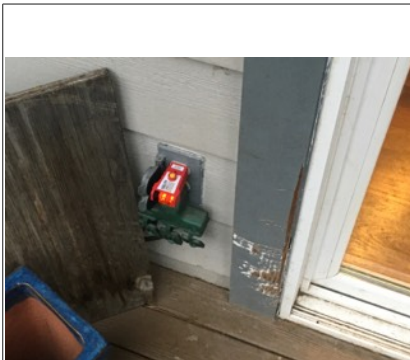
View of tester on exterior outlet.

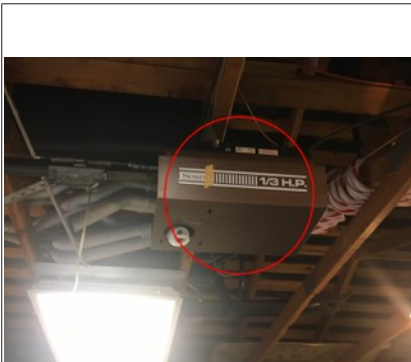
garage door opener may be approaching end of life. Recommend further evaluation/repair by licensed contractor.

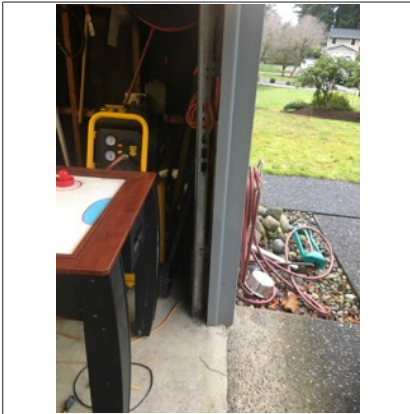
No eye on garage door opener.  
Recommend further  
evaluation/repair by licensed  
contractor. This is a SAFETY  
ISSUE.

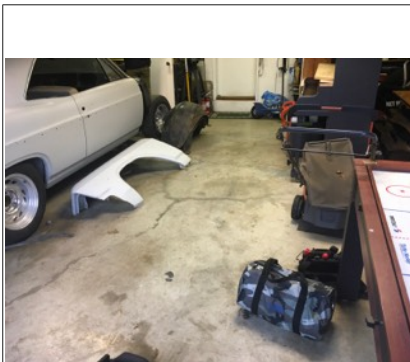
View of garage floor with cracks

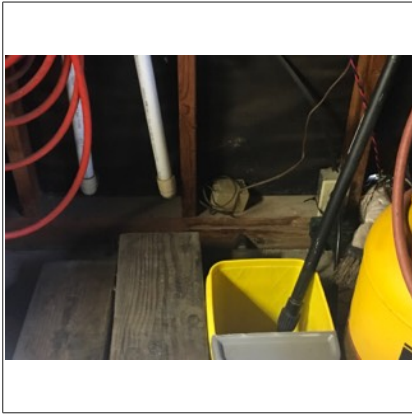
**Overhead Door(s)**

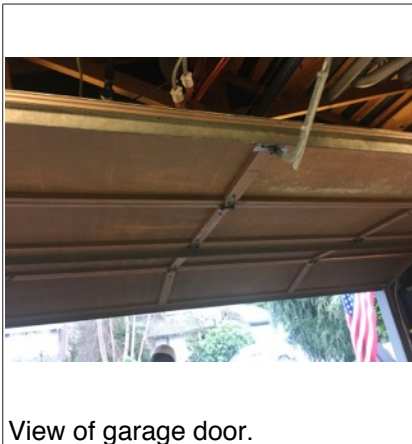
View of garage door.

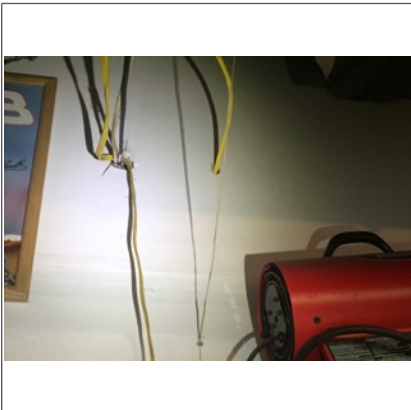
- Recommend repair
- Condition**  Holes walls/ceiling  Safety hazard(s)
- Moisture Stains Present**  No
- Typical Cracks**  Yes
- Fire door**  Not verifiable
- Self closure**  Inoperative
- Comments** The fire separation wall was damaged recommend repair
- Photos**

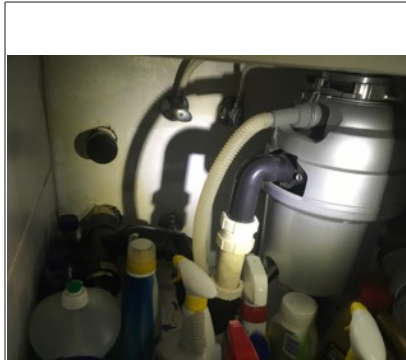
View of plumbing under kitchen sink. There is not an air gap or high loop installed for the dishwasher Recommend further evaluation/repair by licensed plumbing contractor.

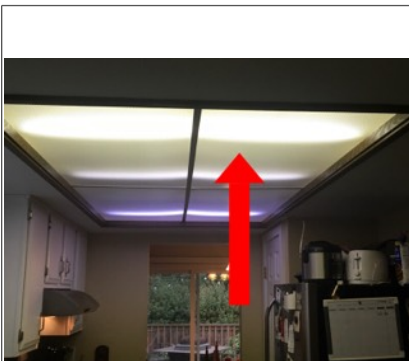
There could be burned out bulbs or lighting ballasts that may not be working. Recommend further evaluation/repair by licensed electrical contractor.

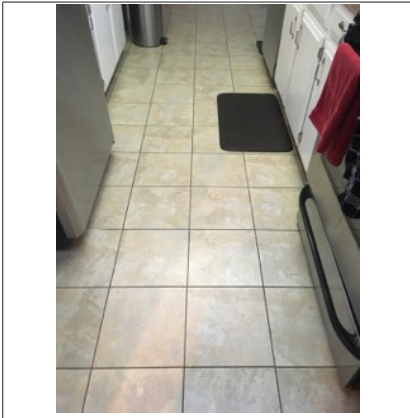
View of floor in kitchen.

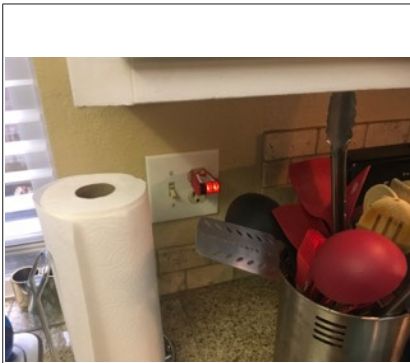
View of working outlet with tester.

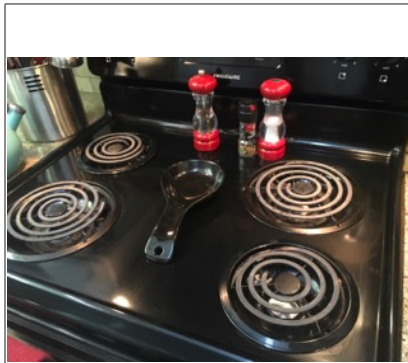
All burners functional on range.

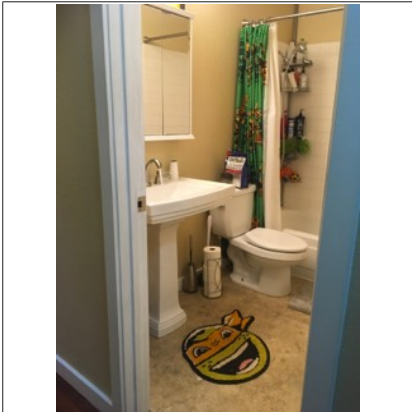
**Toilet** Operable:  Yes Toilet Loose:  No  
**Sink(s)** Operable:  Yes Faucet Leaks:  No Pipes Leak:  No  
**Shower/Tub Combination** Material:  Ceramic/Plastic Condition:  **Marginal** Faucet Leaks:  No Pipes Leak:  No Chalking/Grouting Needed:  Yes  
**Shower**  N/A  
**Garden/Soaking Tub**  N/A  
**Whirlpool Tub**  N/A  
**Water Flow**  **Marginal**  
**Drainage**  **Marginal**  
**Doors**  **Marginal**  
**Windows**  N/A  
**Exhaust Fan** Operable:  No Needs To Be Cleaned:  Yes  
**Electrical** Receptacles Working:  Yes Outlets GCFI:  No Open Ground/Reversed Polarity:  No  
 Recommend GCFI  
**Heat Source Present**  Yes  
**Moisture Stains Present**  No  
**Photos**

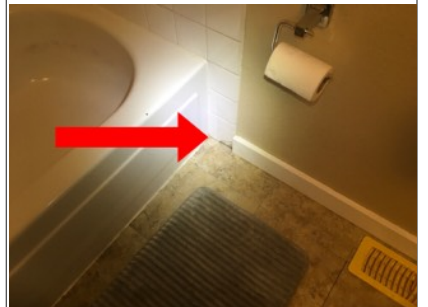
Broken/Missing tile from baseboard in bathroom. Recommend further evaluation/repair from licensed contractor.

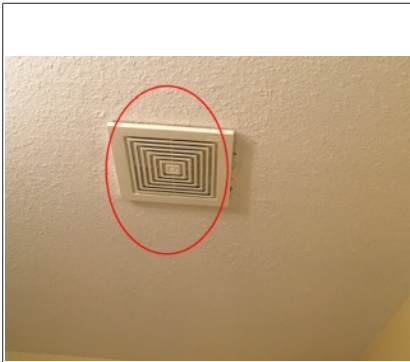
Exhaust fan was not working.  
Recommend further  
evaluation/repair from licensed  
contractor.

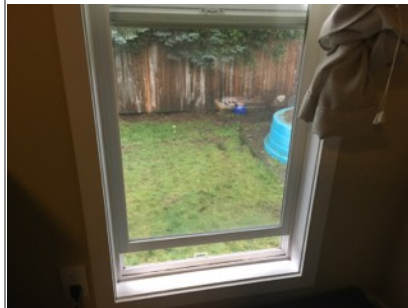
Windows in master bedroom should be installed with safety glass due to lower edge being below 18 inches. Recommend further evaluation/repair from licensed contractor.

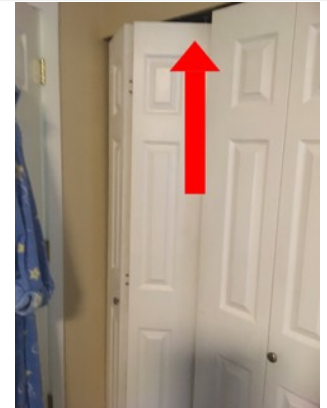
The folding closet door does not properly operate.

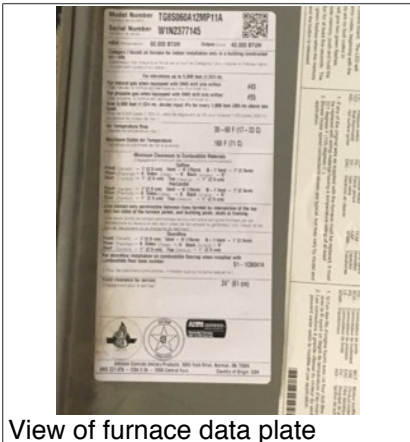
View of furnace data plate

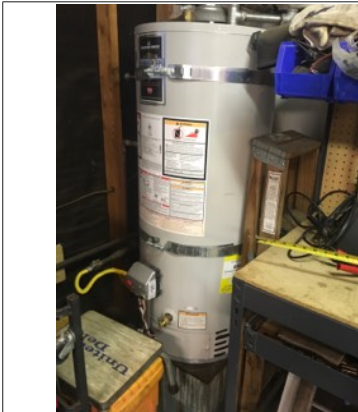
View of water heater with correct seismic straps attached.

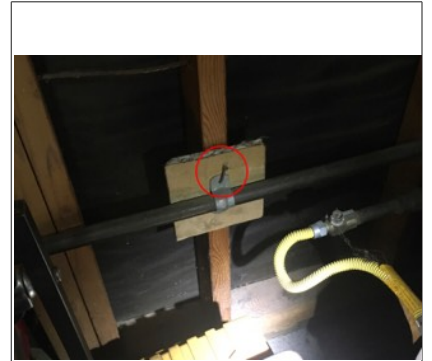
Gas line strap improper attached to wall stud. Recommend further evaluation/repair by licensed plumbing contractor.

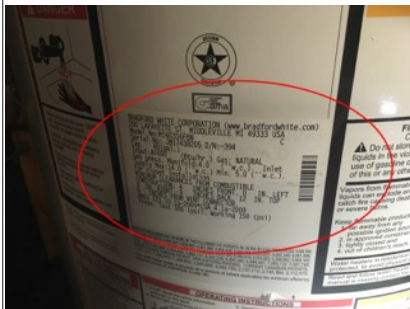
View of data plate on hot water tank.

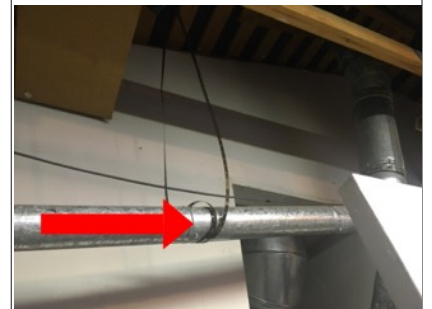
Improper strap attachment to vent pipe. Recommend further evaluation/repair by licensed HVAC contractor.

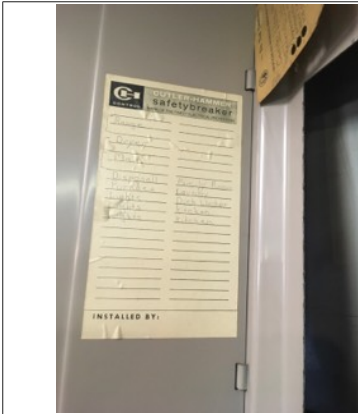
View of breaker data sheet.

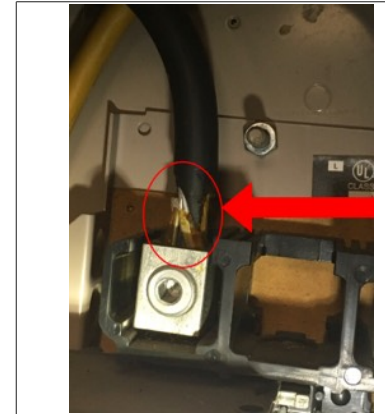
Exposed service entry cable above lug. Recommend further evaluation/repair by licensed electrical a contractor.

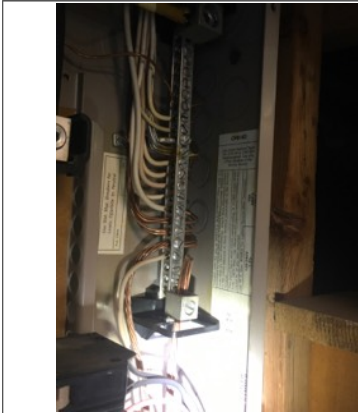
View of inside electrical box data plate

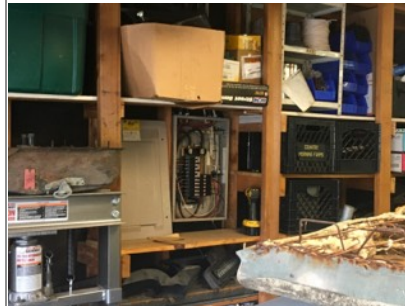
Improper access to electrical panel. Recommend further evaluation/repair by licensed electrical contractor.

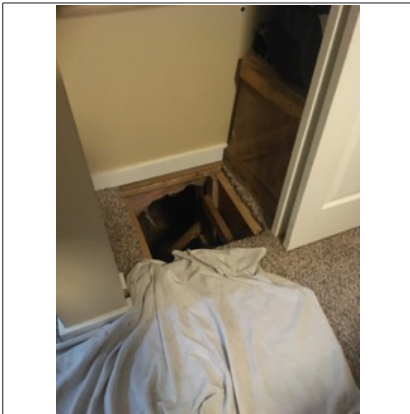
View of access door in bedroom #1 closet

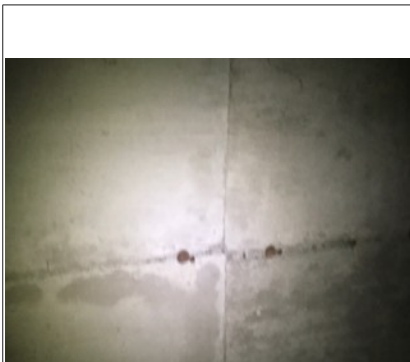
View of poured concrete foundation wall.

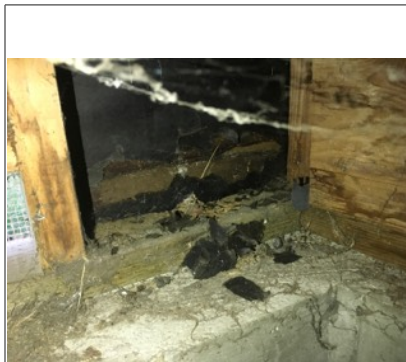
View of damage to sill plate on nw corner of structure.

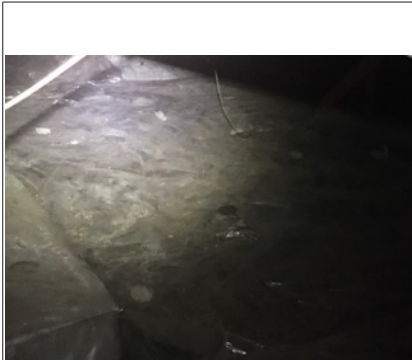
View of floor with vapor barrier.

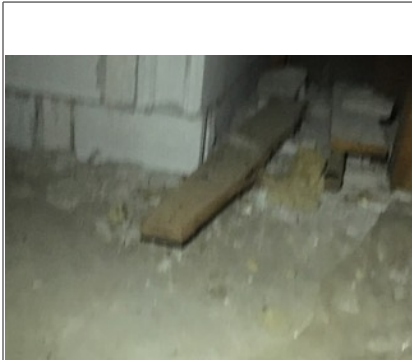
View of conductive material on floor in crawl space and evidence of rodent population. Recommend further evaluation/repair by licensed pest management contractor.

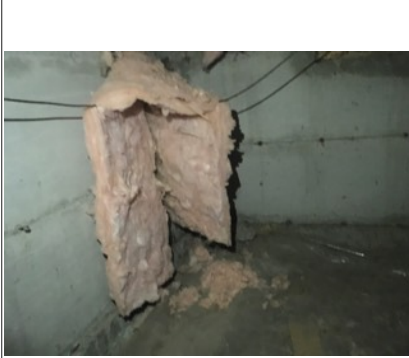
Several areas of loose insulation falling from joists. Recommend further evaluation/repair by licensed contractor.
