Home Inspection Report

, Tulalip, Washington 98271

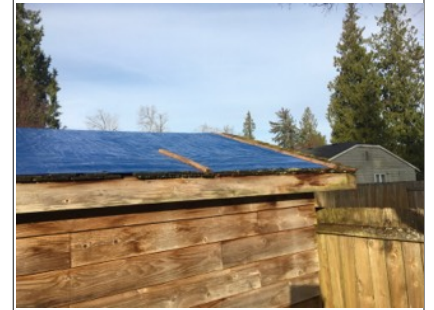
Image of damaged roofing material on shed not evaluated during inspection

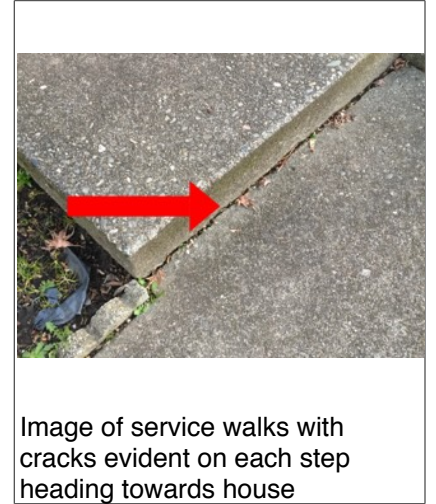
Image of service walks with cracks evident on each step heading towards house

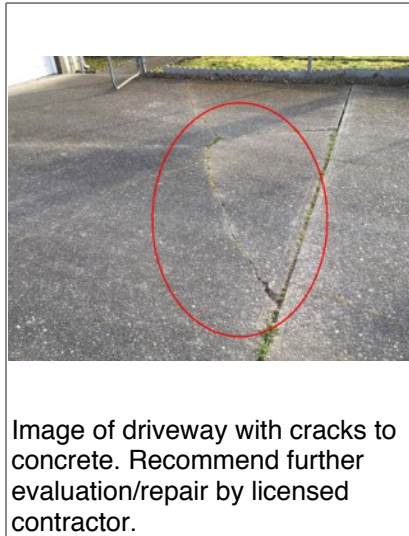
Image of driveway with cracks to concrete. Recommend further evaluation/repair by licensed contractor.

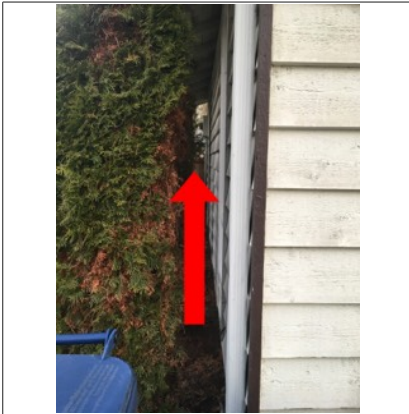
Image of shrubs in close proximity to siding and soffit. Recommend trimming shrubs back to allow for ventilation.

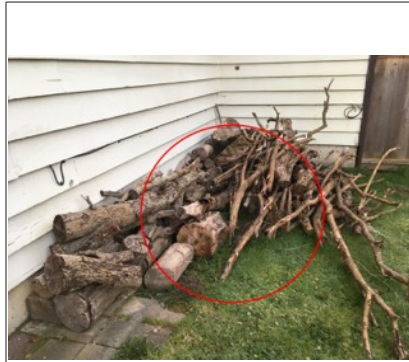
Image of conductive material next to siding/foundation. Recommend moving firewood away from structure to reduce possibility of wood destroying organisms.

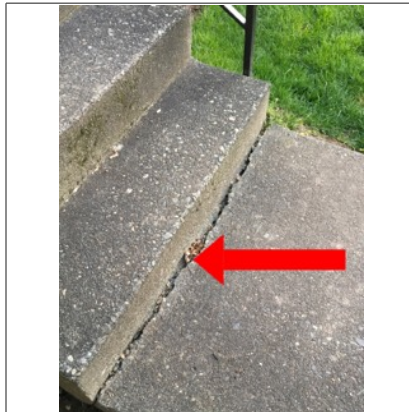
Image of crack at the base of the stairs leading to front door. This crack was probably due to shifting/settling of the stair foundation. Recommend further monitoring.

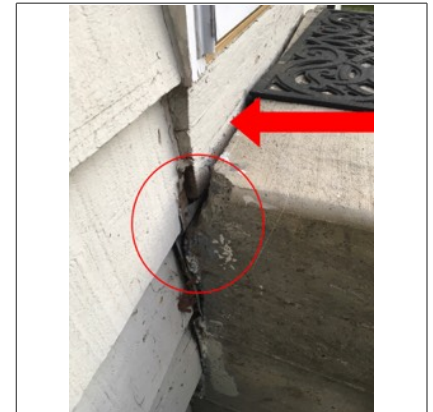
Image of crack at the top of the stairs leading to front door. This crack was probably due to shifting/settling of the stair foundation. Recommend further monitoring.

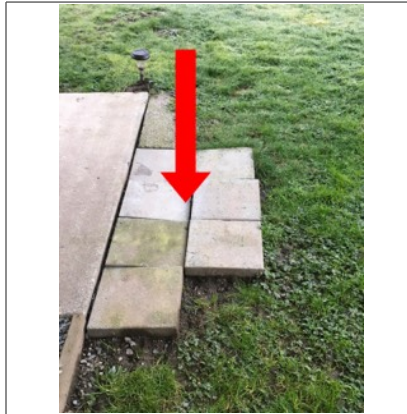
Image of loose and uneven pavers at end of patio. Recommend leveling pavers to reduce trip/fall injury

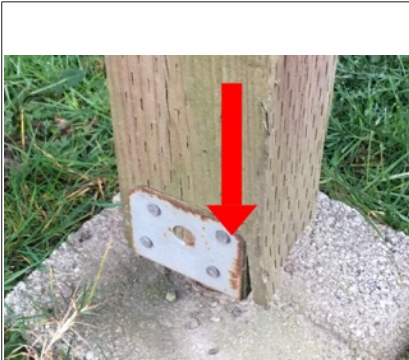
Image of rusted deck post bracket and slight damaged to wood on lower right corner. Recommend further evaluation/repair by licensed contractor.

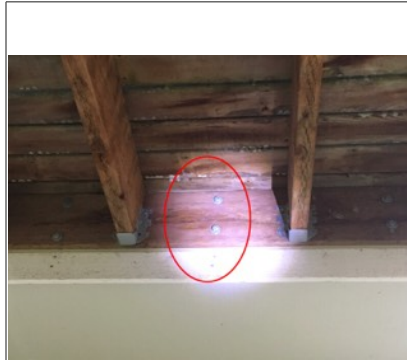
There should be 2" spacing of the fasteners from the ledge board edge and 5" staggered between fasteners. Recommend further evaluation/repair by licensed contractor.

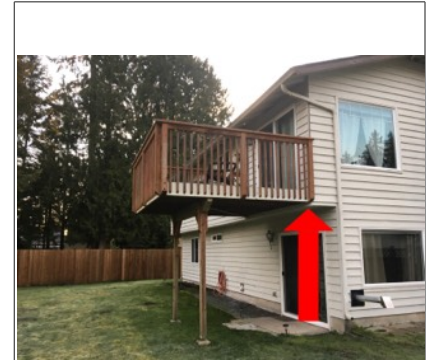
Image of the cantilevered deck attached to the cantilevered section of the house. See statement.

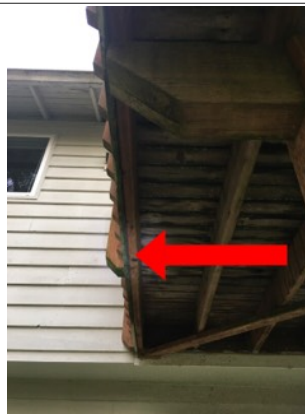
Image of bowed floor joist. Recommend further evaluation/repair by licensed contractor.

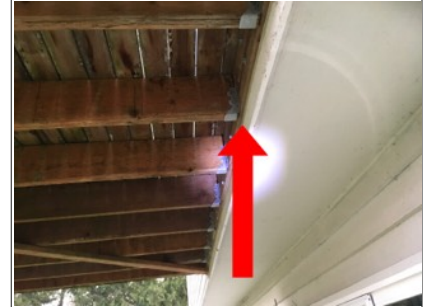
Image of improperly installed caulking under the ledger board. Water that drops down from the top of the ledger board could become trapped by the caulking on the bottom. Recommend further evaluation/repair by licensed contractor.

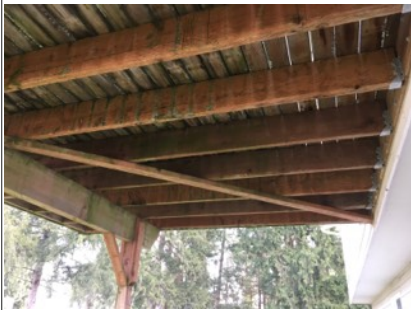
Image of cross-bracing of deck

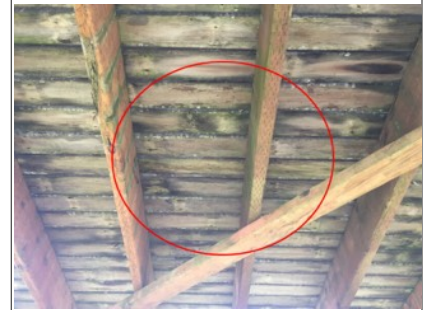
Image of potential wood deterioration of decking surface. Recommend further evaluation/repair by licensed contractor.

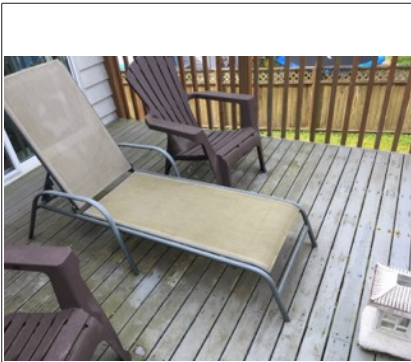
Image of deck surface.

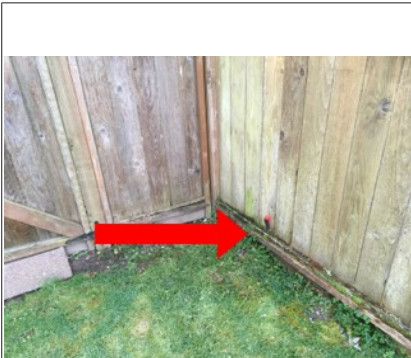
Image of wood rot along bottom of fence.

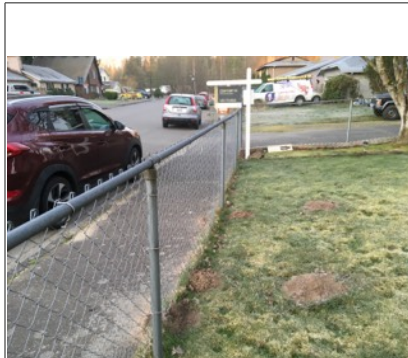
Image of chain link fence on front of property

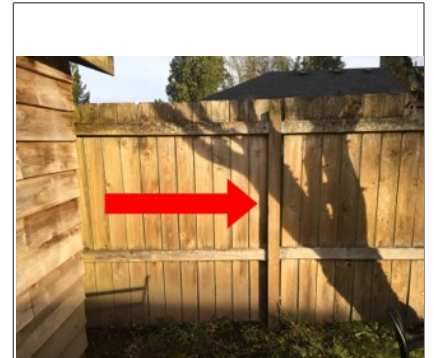
Image of loose fence post on south side of property. Recommend further monitoring.

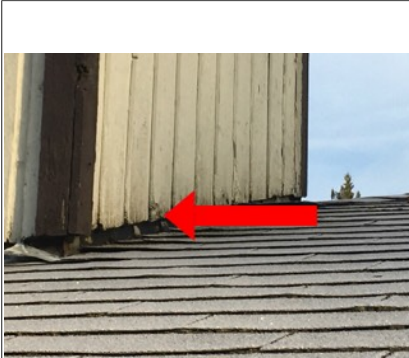
Image of possible wood deterioration on chimney enclosure on west side of chase. Recommend further evaluation/repair by licensed contractor.

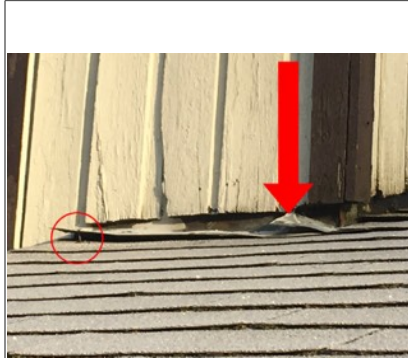
Image of loose flashing around chimney enclosure (Arrow) and nail coming out roof/flashing (Circle). Recommend further evaluation/repair by licensed roofing contractor.

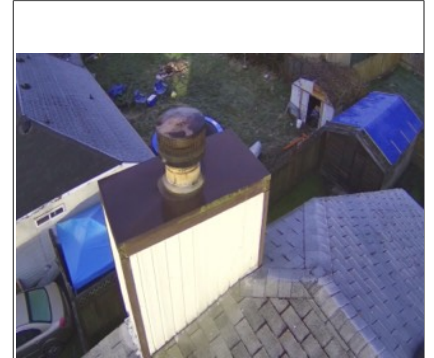
Image of metal chimney cap with spark arrestor in place.

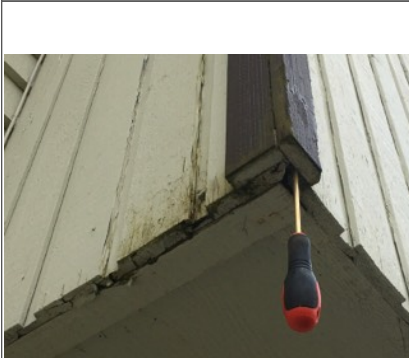
Image of wood rot on bottom of chimney enclosure. Recommend further evaluation/repair by licensed contractor.

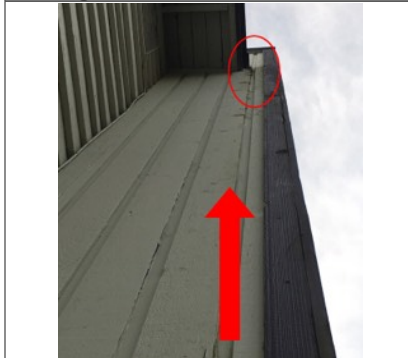
Image of potential wood damage along chimney enclosure. Potential issue extends from the top of the enclosure/roof joint to bottom of enclosure.

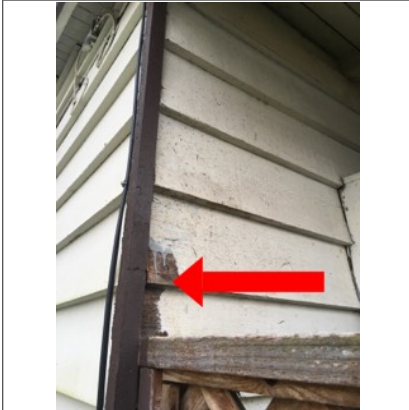
Image of deterioration of paint on several locations on the exterior of the home. Recommend repair by licensed painting contractor. I did not detect wood rot at this location featured in the photograph.

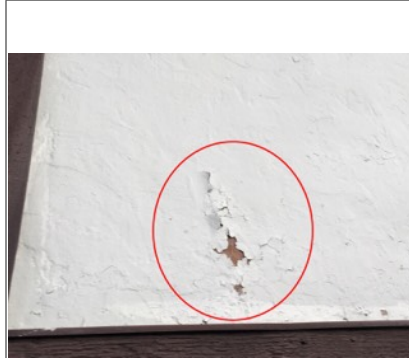
Image of deterioration of paint on several locations on the exterior of the home. Recommend repair by licensed painting contractor. I did not detect wood rot at this location featured in the photograph.

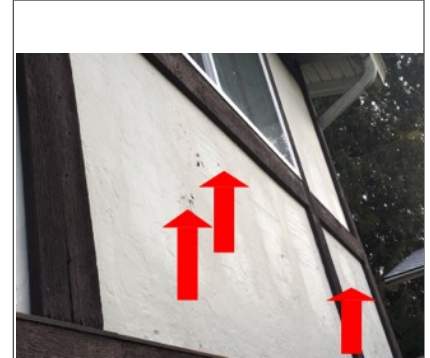
Image of deterioration of paint on several locations on the exterior of the home. Recommend repair by licensed painting contractor. I did not detect wood rot at this location featured in the photograph.

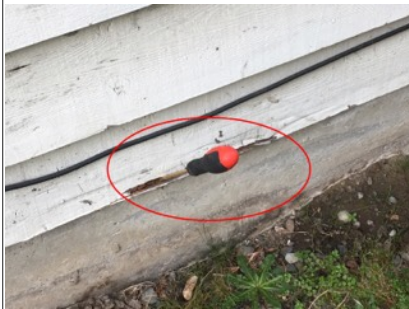
Image of wood rot on west side of building. Recommend repair by licensed contractor.

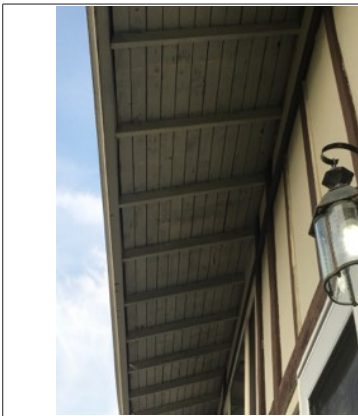
Image of wood soffit.

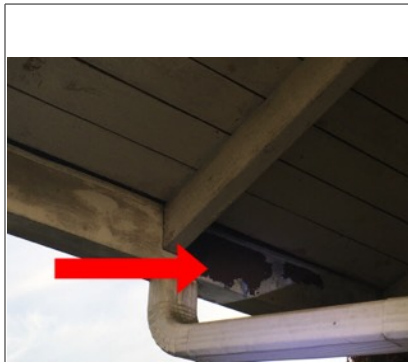
Image of damaged paint on soffit/facia near downspout. Recommend further evaluation/repair by licensed contractor.

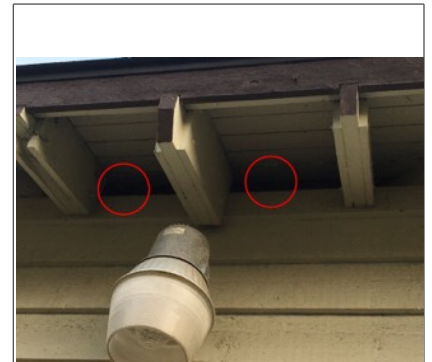
Recommend installing mesh on soffit (above garage) to prevent insect/critter nesting.

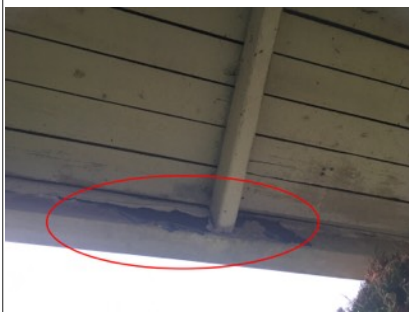
Image of damaged paint on soffit/facia boards. Recommend further evaluation/repair by licensed contractor.

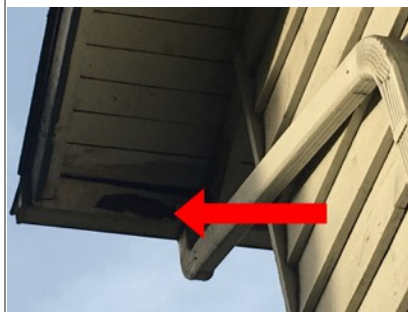
Image of damaged paint on soffit/facia near downspout. Recommend further evaluation/repair by licensed contractor.

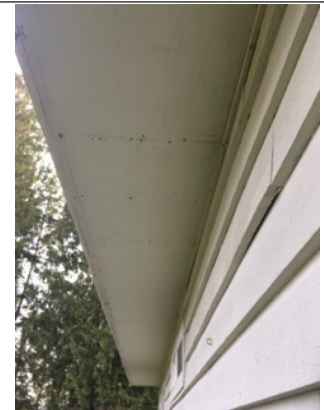
Image of soffit (above 1st story)

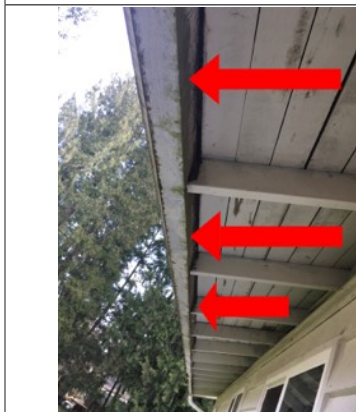
Image of damaged paint on soffit/facia. Recommend further evaluation/repair by licensed contractor.

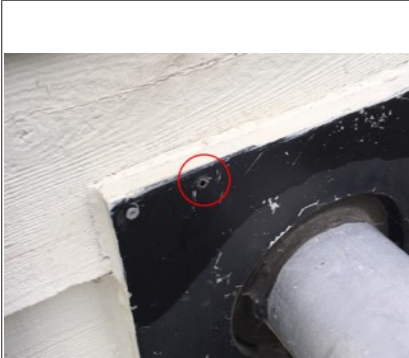
Image of missing screw on heater exhaust vent. Recommend replacing missing screw.

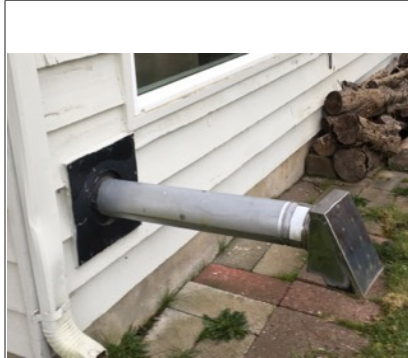
Image of heater exhaust vent outside family room.

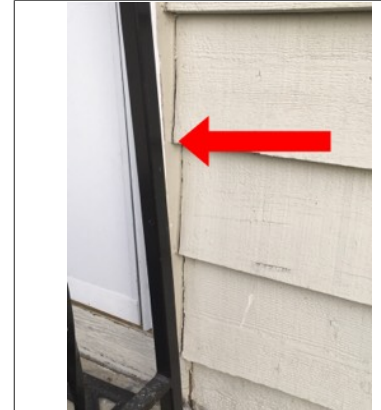
Recommend chasing/sealing around doors, windows, penetrations, and siding joints.

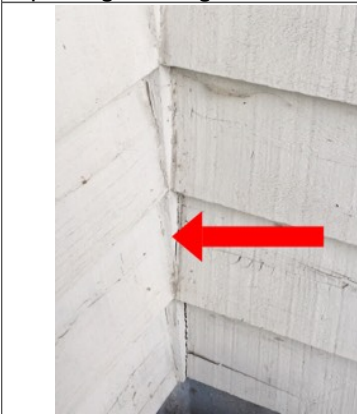
Recommend chasing/sealing around doors, windows, penetrations, and siding joints.

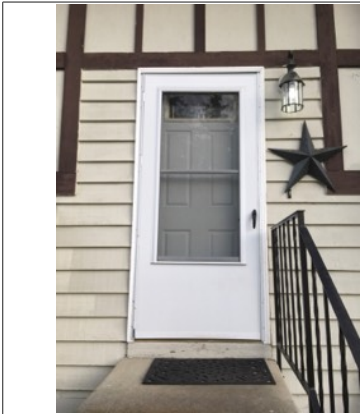
Image of front door with screen door attached.

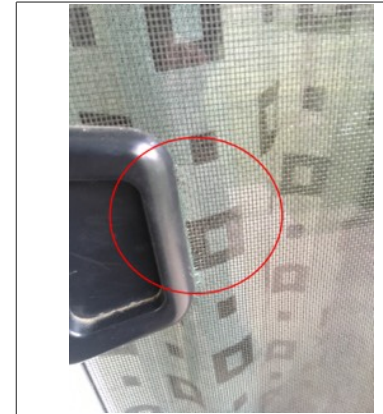
Image of damaged screen on patio door. Recommend replacing screen.

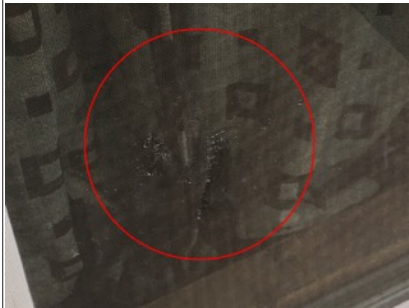
Image of damaged screen on patio door. Recommend replacing screen.

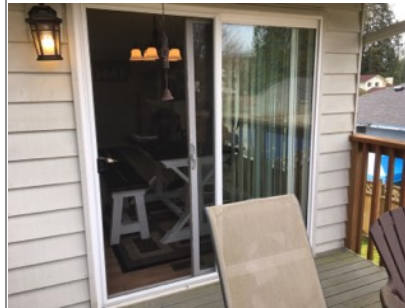
Image of sliding glass door ending to patio.

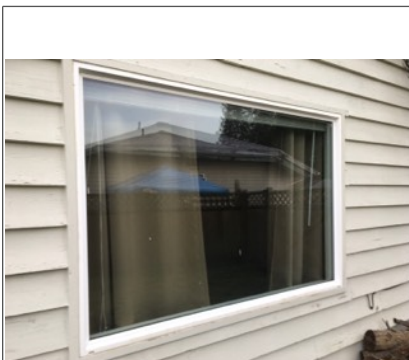
Image of exterior window. Flashing is not installed around exterior windows.

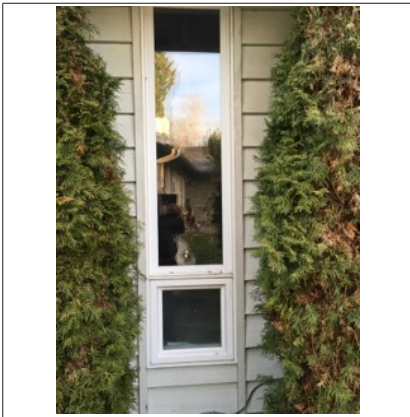
Image of exterior window.
Flashing is not installed around exterior windows.

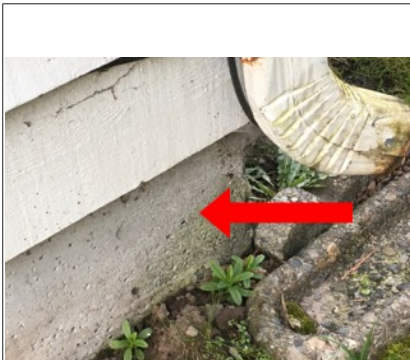
Slight deterioration/pitting of foundation wall around downspouts. Recommend repair of downspout and extend drainpipe away from foundation. Recommend further monitoring of foundation wall.

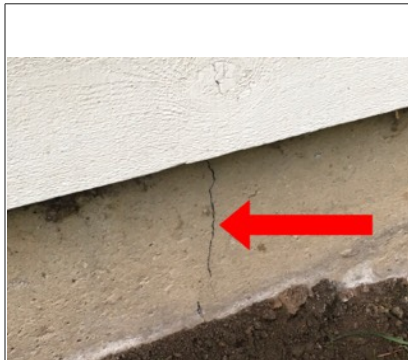
Image of foundation crack on west side of building. This crack does not appear to be structural in nature. Recommend sealing crack to prevent water intrusion.

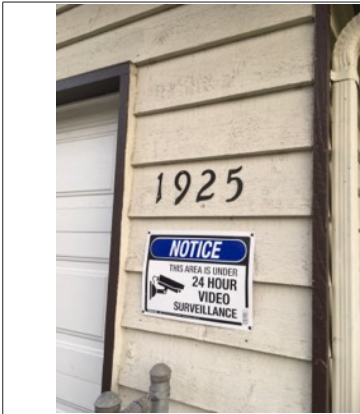
Image of house numbers on front of house.

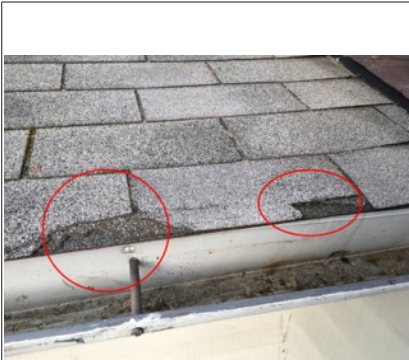
Image of damaged roof shingles near entry door. Recommend further evaluation/repair by licensed roofing contractor.

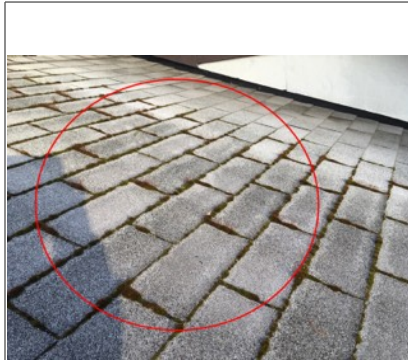
Image of moss build-up on roofing material. Recommend removing moss from roofing material.

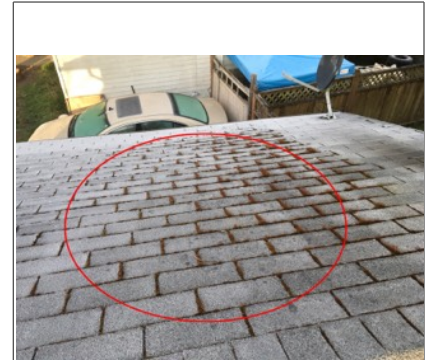
Image of moss build-up on roofing material. Recommend removing moss from roofing material.

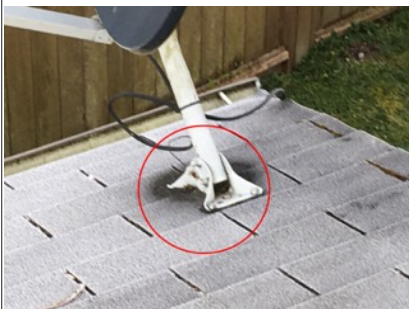
Image of satellite dish on east side of building, Recommend sealing screw holes to prevent water intrusion into roof structure.

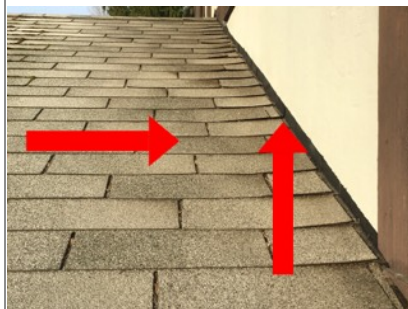
Image of light curling of asphalt shingles on garage roof. Recommend further monitoring.

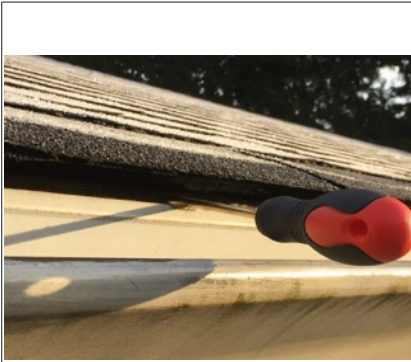
Image of missing drip edge flashing on roof. There are several locations that have exposed felt along the roof intersection with the gutter, Recommend further evaluation/repair by licensed roofing contractor.

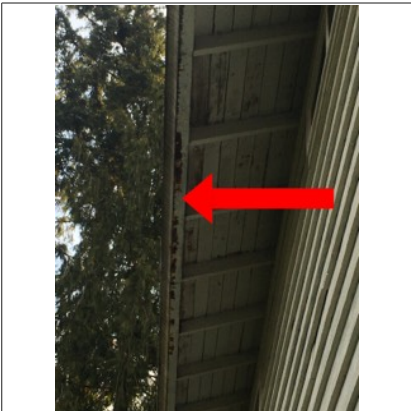
Image of rusted gutters on the south side of the home. Recommend further evaluation/repair by licensed contractor.

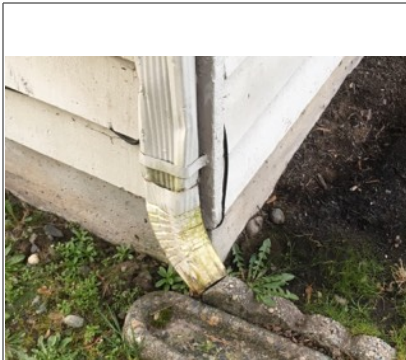
Image of damaged downspout. Recommend repair and added extension away from the house (by three feet).

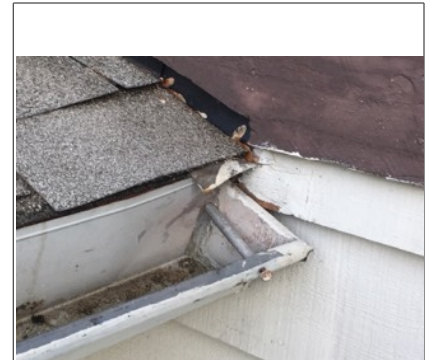
Image of missing kick-out flashing on roof. Recommend further evaluation/repair by licensed contractor.

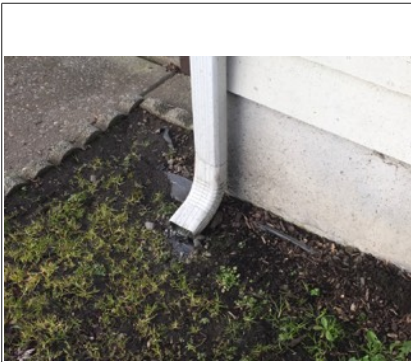
Image of downspout. Downspout may need extension away from structure. Recommend monitoring.

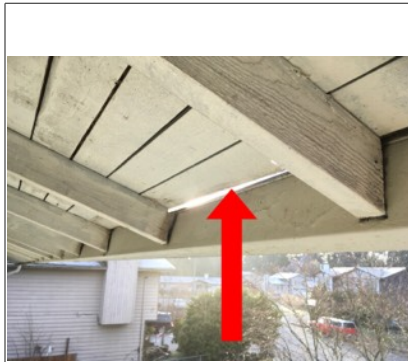
Image of the gutter detaching from the fascia board on the front side of the house. Recommend further evaluation/repair by licensed contractor.

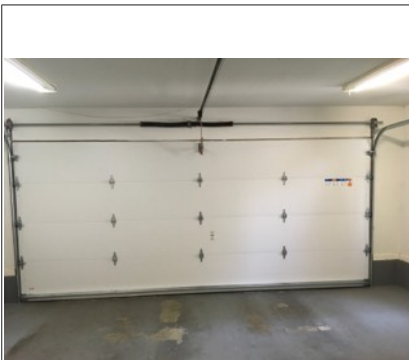
View of garage door (interior)

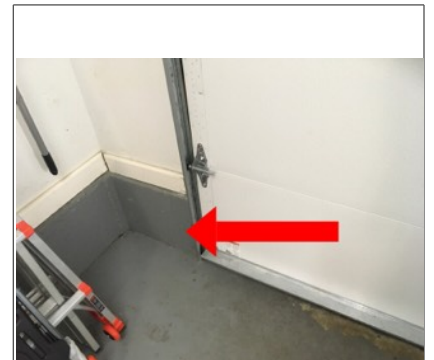
Image of missing eye sensor on door opener. This is a potential SAFETY HAZARD and recommend repair by licensed contractor.

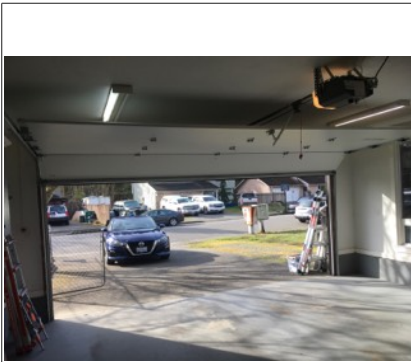
Image of garage door opener operation.

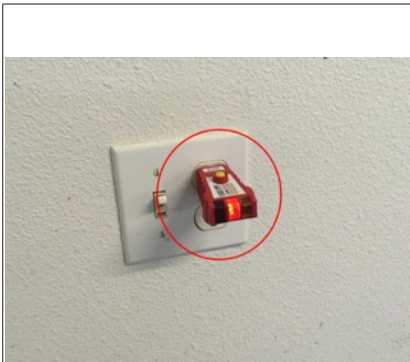
Image of tested electrical receptacle. The outlet on the east side of the garage, near the garage door, has an open ground. Recommend further evaluation/repair by licensed electrical contractor.

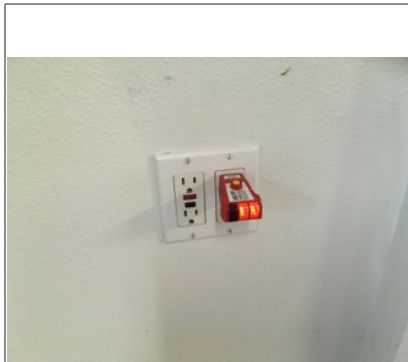
Image of tested GFCI receptacle in garage.

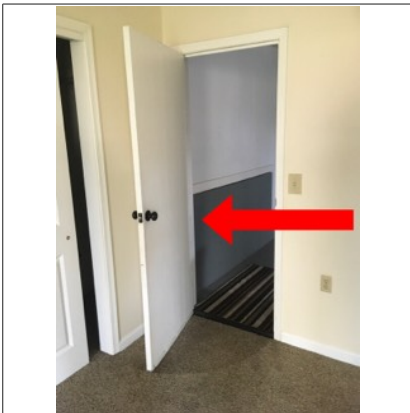
The garage door does not automatically close after it is open. This is a potential SAFETY HAZARD and recommend repair by licensed contractor.

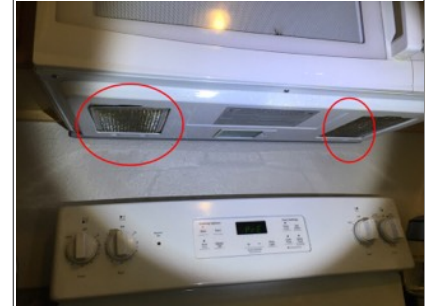
Image of grease filters for exhaust fan. Recommend periodic cleaning to help airflow.

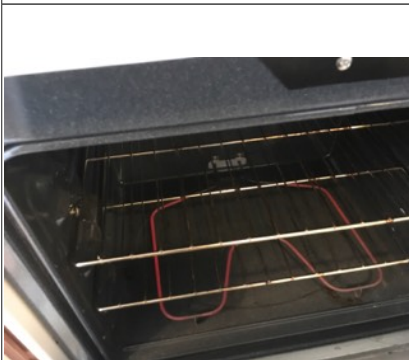
Image of functional heating elements in oven.

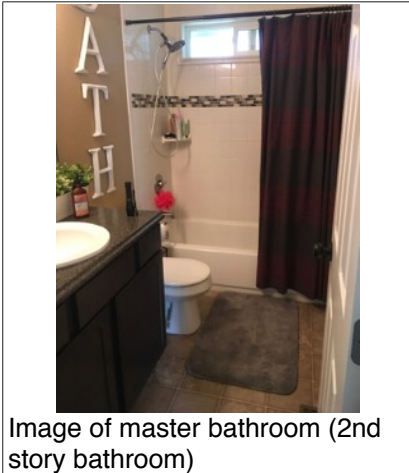
Image of master bathroom (2nd story bathroom)

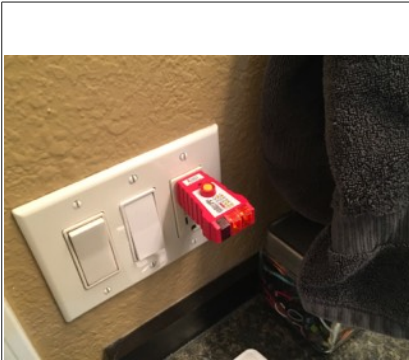
Image of tested GFCI electrical receptacle.

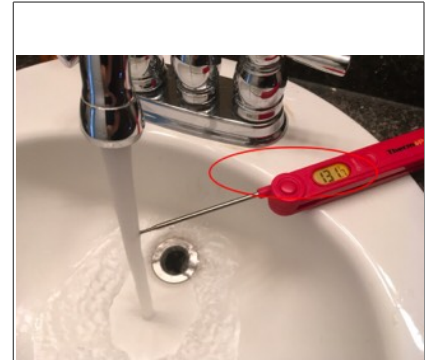
Image of water temperature test. The water is above 120 degrees and this is a potential SAFETY HAZARD. Recommend reducing temperature on hot water tank. If temperature cannot be adjusted the recommend repair by licensed plumbing contractor.

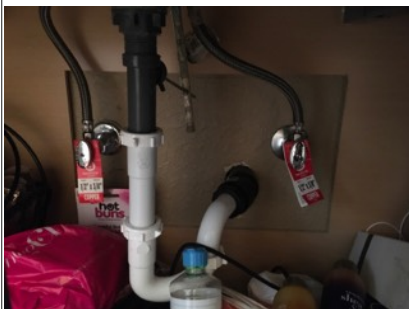
Image of plumbing under sink

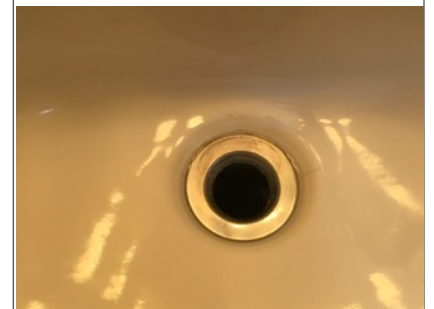
Image of missing sink stopper. Recommend replacement.

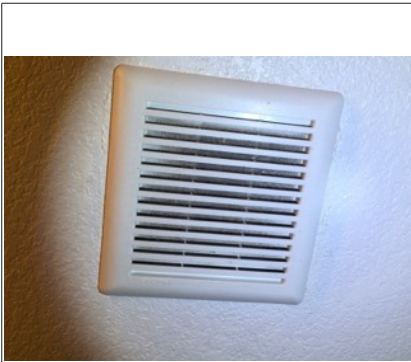
Image of exhaust fan.

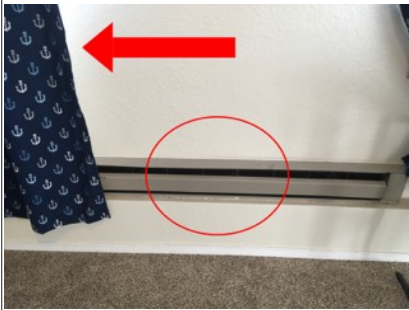
This bedroom is equipped with baseboard heating. Recommend that drapes do not come into contact with heater and there is a 6 inch gap between elements and fabric. This is a potential SAFETY HAZARD.

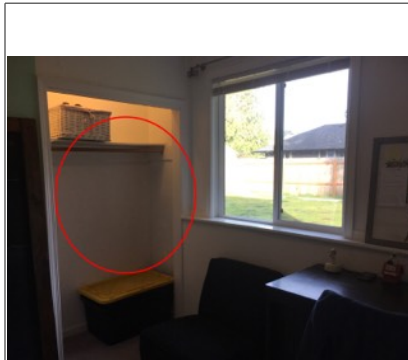
Image of missing closet doors.

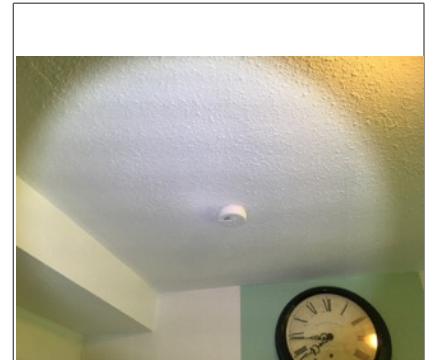
Image of smoke detector

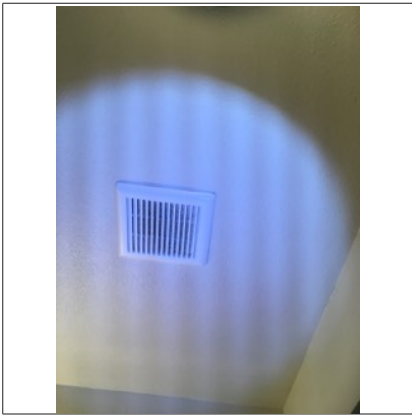
Bathroom Bathing Enclosure

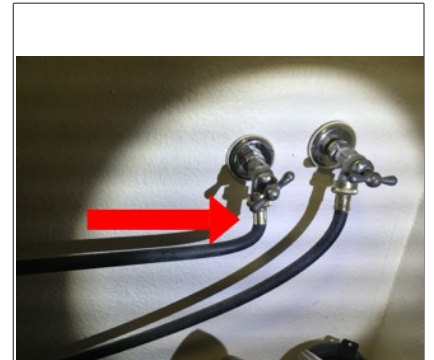
Recommend lengthening water line to washing machine. Stretched water lines are prone to rupture. Recommend replacing water line.

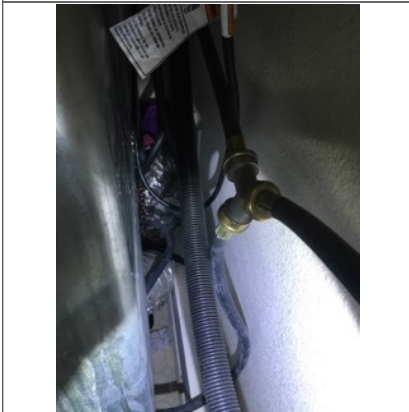
Image of clothes dryer exhaust duct

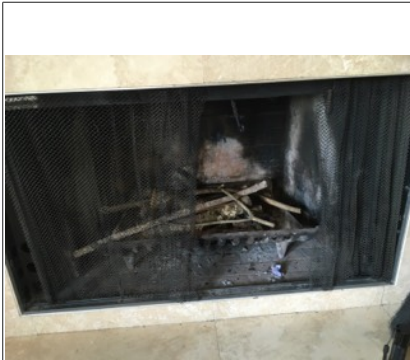
Image of fireplace with mesh screens

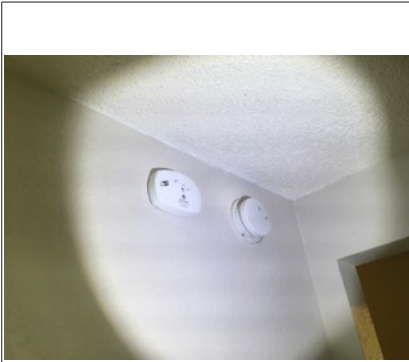
Image of smoke and carbon monoxide detectors

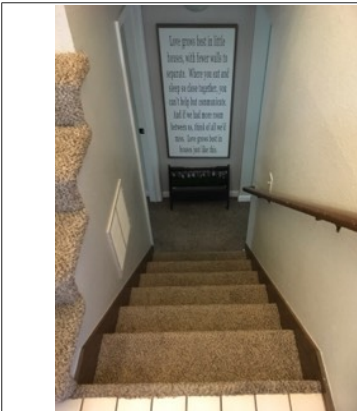
Image of stairs going down to 1st floor (front landing).

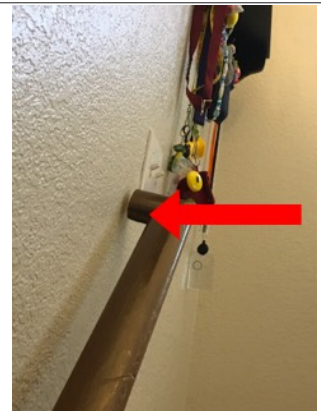
Railing should completely return to wall. This gap could cause clothing to snag on opening and present a trip/fall hazard.

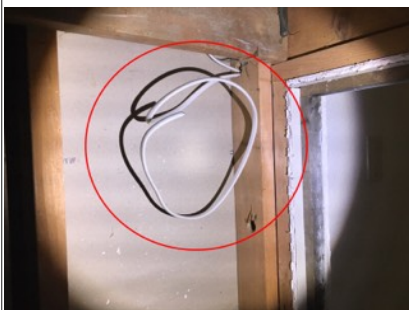
Image of exposed wires under stairs. I tested it and there is no power to this wire. Recommend removal of wire.

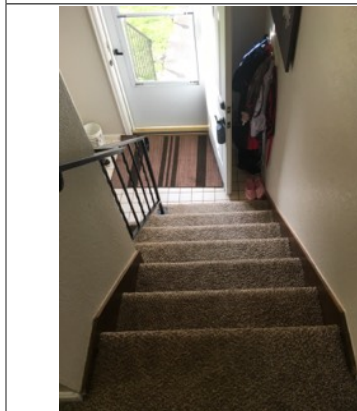
Image of top of stairs to landing

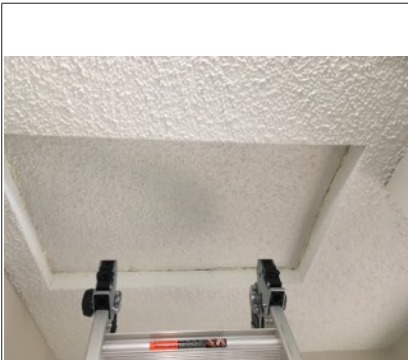
Access hatch to attic outside master bedroom

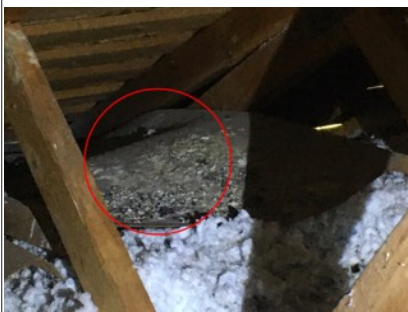
Image of past nesting of birds/animals. Recommend further monitoring.

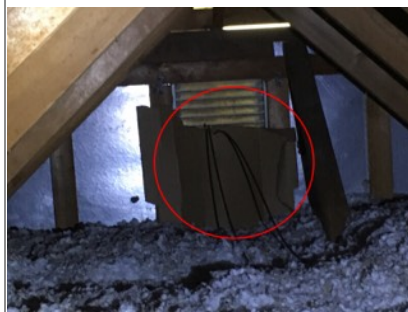
Image of gable vent being blocked by cardboard baffle. Recommend removing cardboard to allow better airflow in attic.

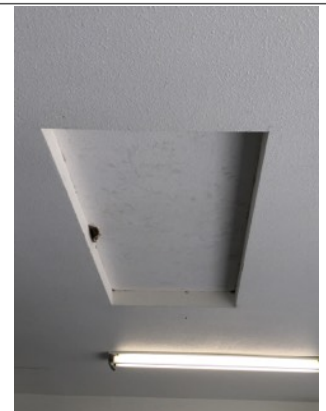
Image of attic hatch in garage

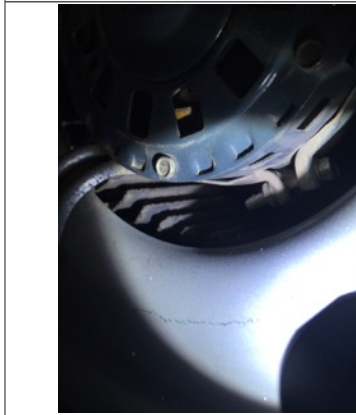
Image of dust on the squirrel cage fan/housing. Recommend cleaning by licensed HVAC contractor.

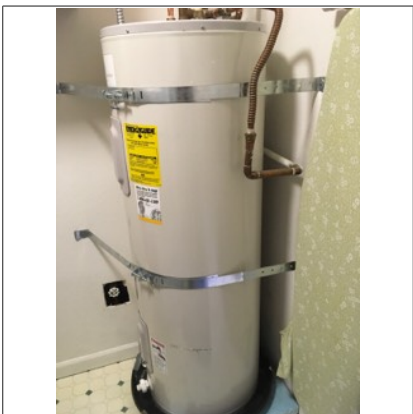
Image of water heater with proper restraints.

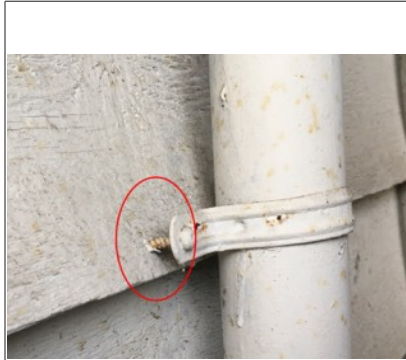
Image of loose screws on electrical conduit. Recommend repair by licensed contractor.

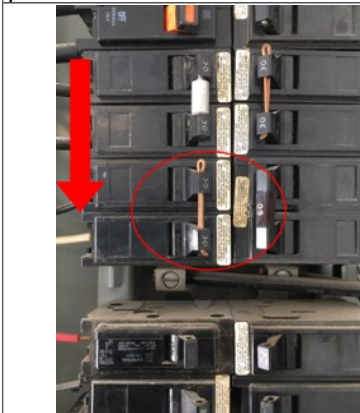
Image of potentially overheating breaker (see thermal image). This breaker has 30 amp supply but conductors appear to be undersized for amps. Recommend further evaluation/repair by licensed electrical contractor.

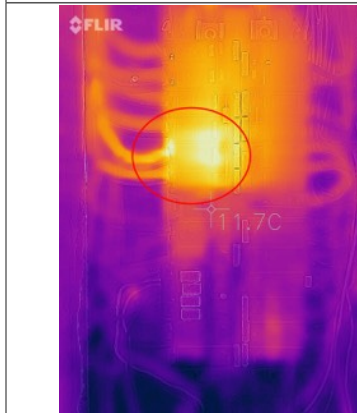
Image of excessive heat being generated on breaker 30 amp breaker that is running hot water tank. Recommend further evaluation/repair by licensed electrical contractor.

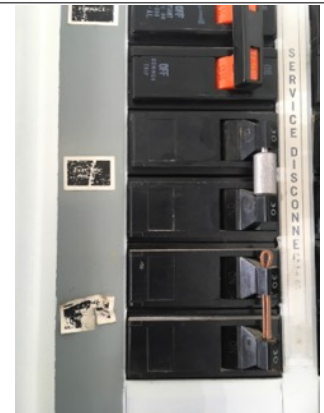
Image of 30 amp breaker in question (hot water tank)
