Home Inspection Report

, Blaine, Washington 98230

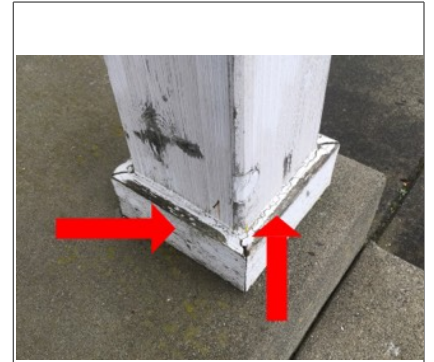
Image of porch cover column. The wood trim on the bottom of the column appears to have moisture intrusion. Recommend sealing and re-painting to prevent further moisture from entering wood.

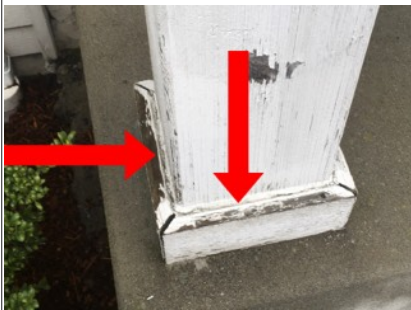
Image of porch cover column. The wood trim on the bottom of the column appears to have moisture intrusion. Recommend sealing and re-painting to prevent further moisture from entering wood.

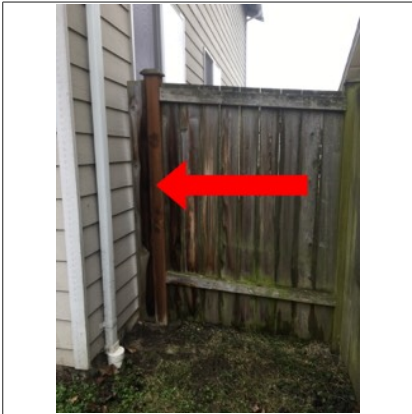
View of fence/fence post on west side of building. The post is slightly loose and I would recommend further monitoring.

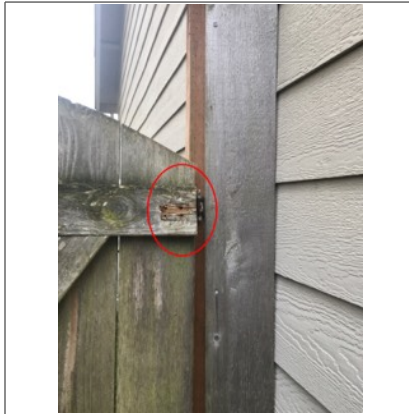
The fence door/gate is missing hardware to lock gate. Recommend repair/replacement by licensed contractor. The fence door binds against the post.

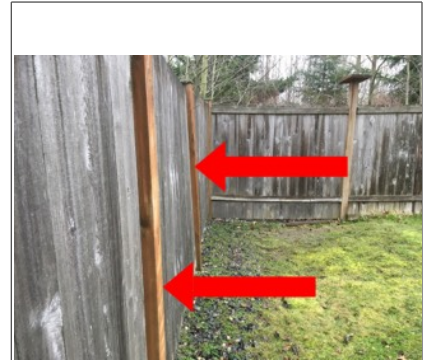
There are several fence posts located in the backyard that are leaning improperly. Recommend further evaluation/repair by licensed fencing contractor.

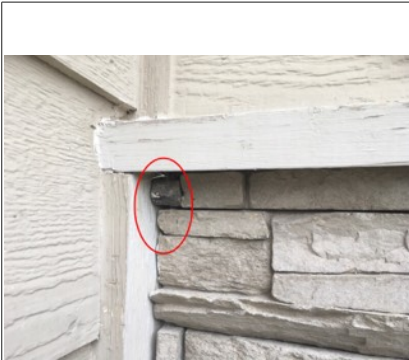
There are several loose pieces of applied masonry veneer on the right column next to the garage door. Recommend further evaluation/repair by licensed contractor.

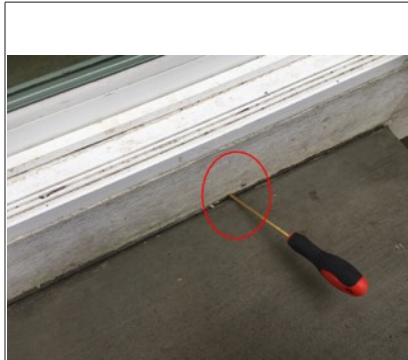
Image of trim piece below sliding glass door. There appears to be moisture intrusion into the trim board below the sliding glass door. Recommend further evaluation/repair by licensed contractor.

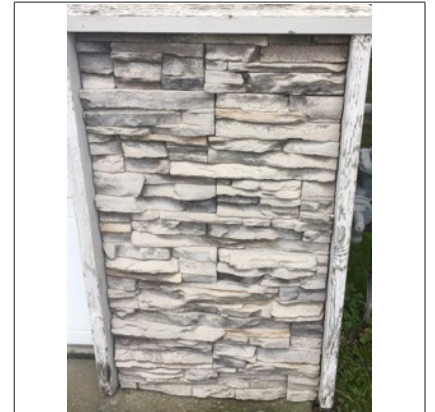
Image of applied masonry (stone) veneer.

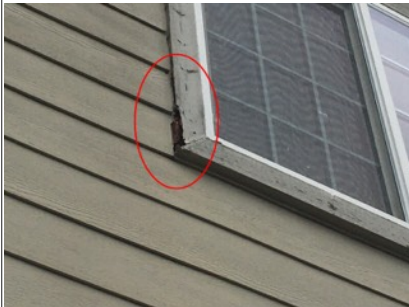
Trim board is damaged and has evidence of wood deterioration. Recommend further evaluation/repair by licensed contractor.

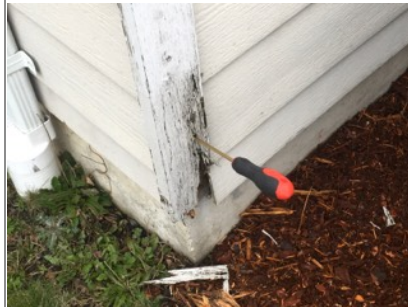
Image of damaged trim on south side of building. Recommend further evaluation/repair by licensed contractor.

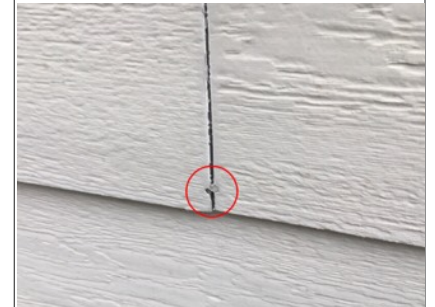
There are several locations of improper nailing of siding. Recommend monitoring for possible water intrusion.

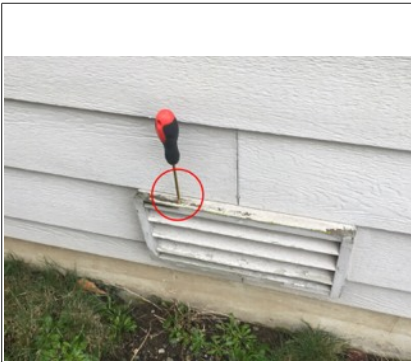
Image of damaged trim on west side of building. Recommend further evaluation/repair by licensed contractor.

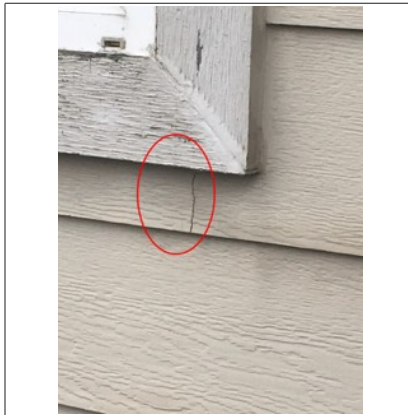
Crack on siding board. Recommend sealing to prevent water intrusion.

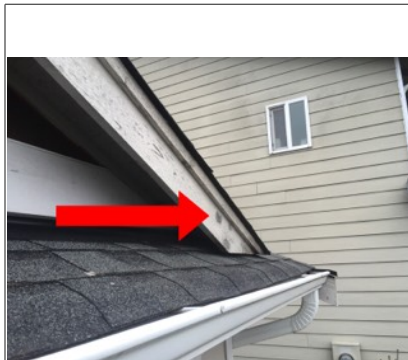
Image of fascia board on front of house. Recommend sealing/painting to reduce water penetration into wood.

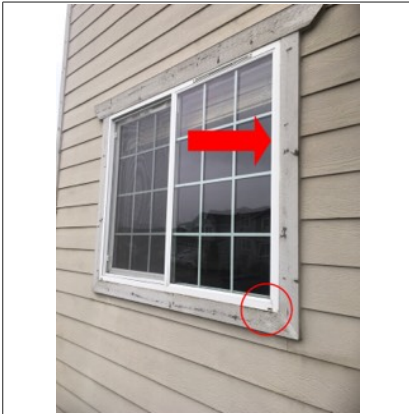
Check caulking around windows and doors along this edge.

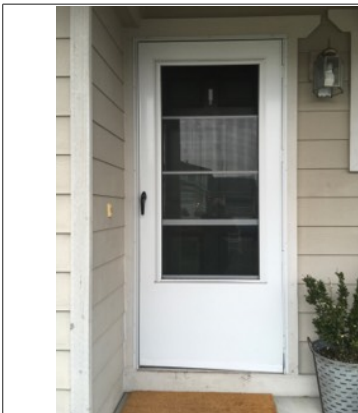
Image of storm door on front entry way.

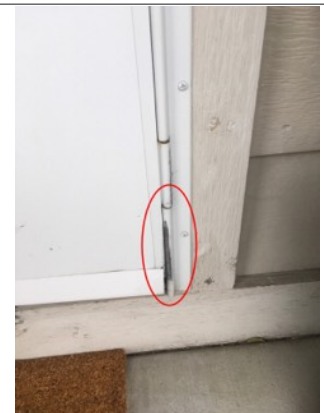
There appears to be rubbing around the hinge on the entryway storm door. Recommend further monitoring.

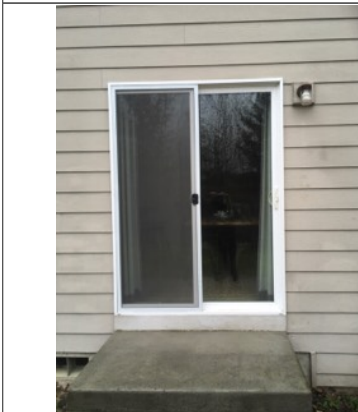
Image of patio sliding glass door.

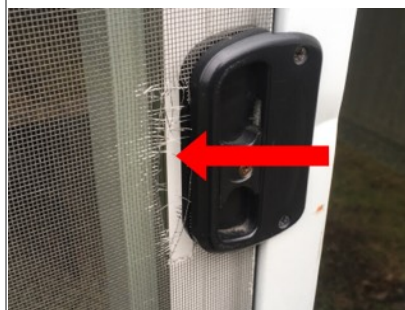
Image of damage to screen on sliding glass door. Recommend further evaluation/repair by licensed contractor.

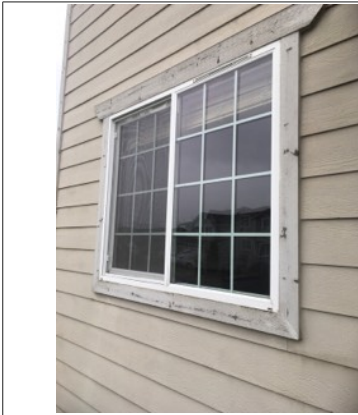
Image of exterior window. All windows are same make/material as picture in this photo.

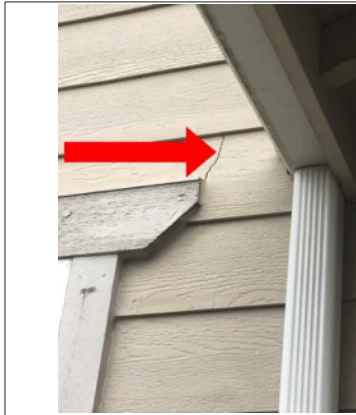
There is a crack in the siding above the window located on right side of the front of structure. This crack could be allowing water/moisture to enter the wall envelope. Recommend further evaluation/repair by licensed contractor.

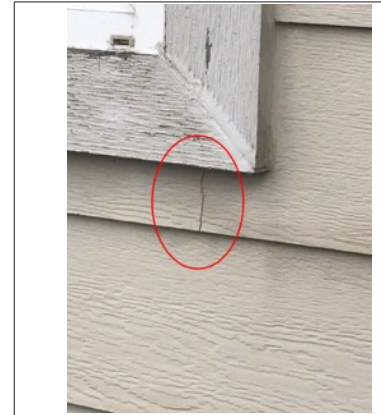
There is a crack in the siding below the window located on right side of the front of structure. This crack could be allowing water/moisture to enter the wall envelope. Recommend further evaluation/repair by licensed contractor.

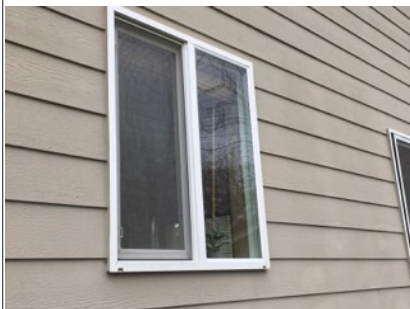
View of window in back of house.

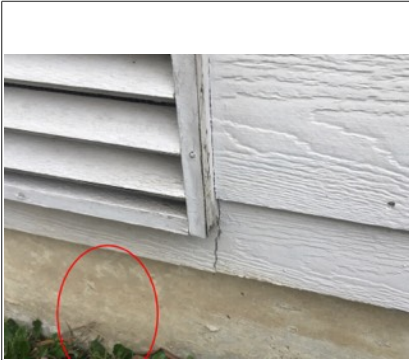
Image of poured concrete foundation.

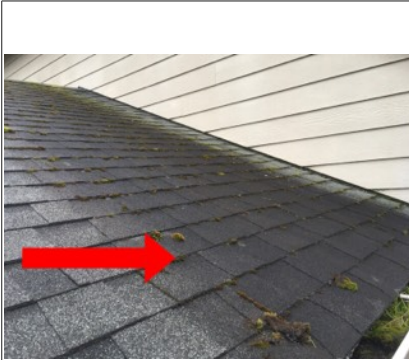
Moss (mold) build-up on roof coverings. Recommend further evaluation by licensed roofing contractor.

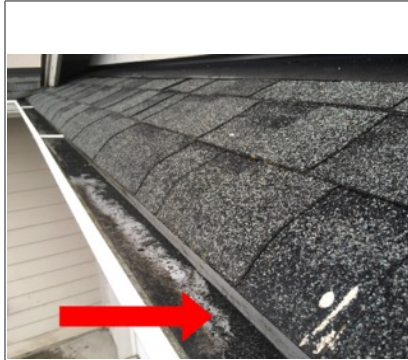
Asphalt shingle granules are evident in gutter system.

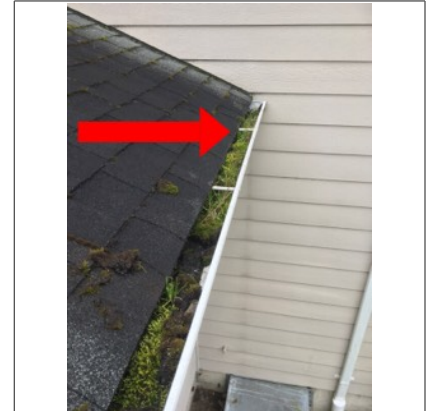
There is build-up in the gutter on the north side of the building. Recommend cleaning out debris.

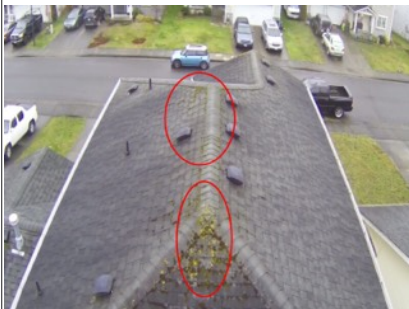
Moss/Mold build-up on roofing materials. Recommend further evaluation/repair by licensed roofing contractor.

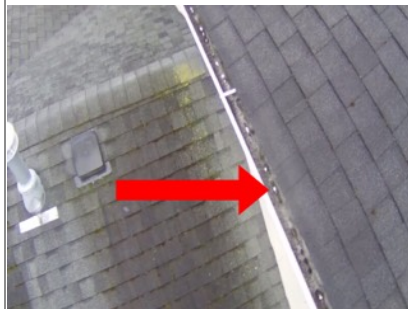
Asphalt shingle granules evident in gutter system.

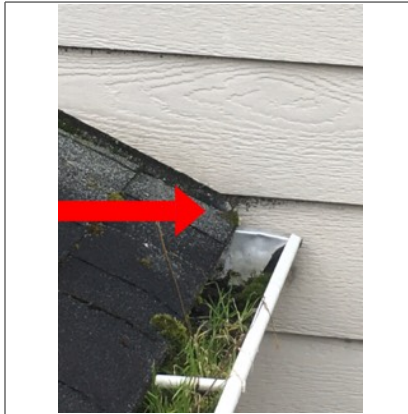
Missing kick out roof flashing. Recommend further evaluation/repair by licensed roofing contractor.

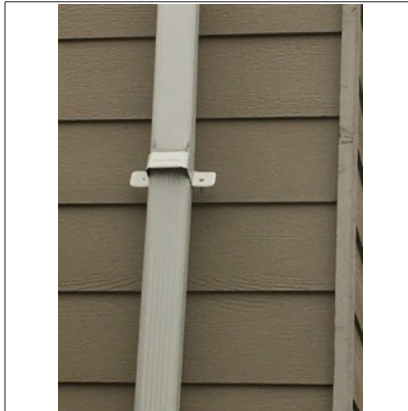
Loose downspout attachment. Recommend further evaluation/repair by licensed contractor.

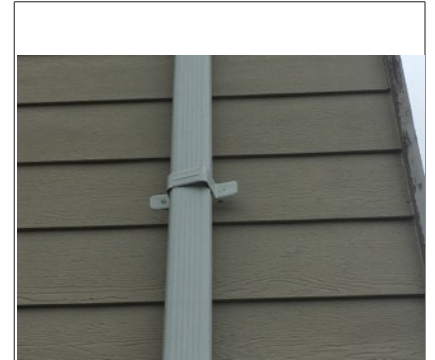
Loose downspout attachment. Recommend further evaluation/repair by licensed contractor.

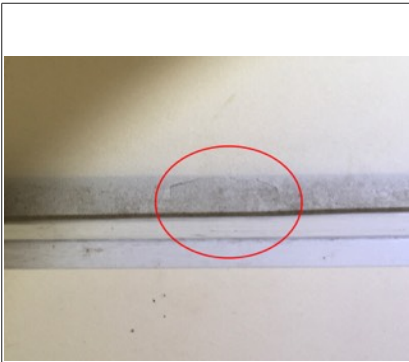
There are several cracks on the insulated panel on the garage door (interior side) Recommend further monitoring.

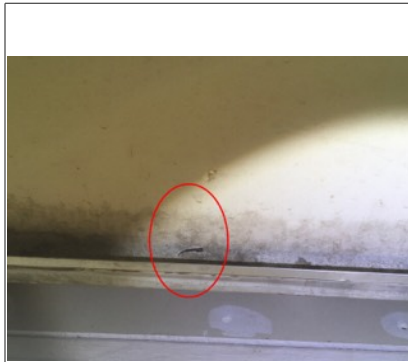
There are several cracks on the insulated panel on the garage door (interior side) Recommend further monitoring.

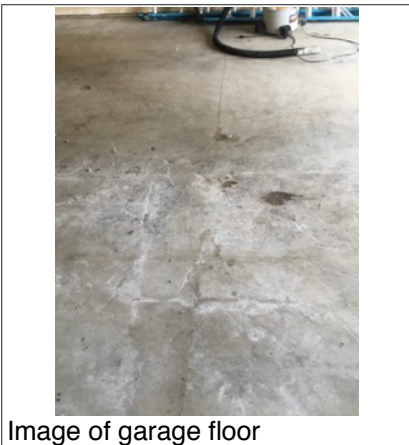
Image of garage floor

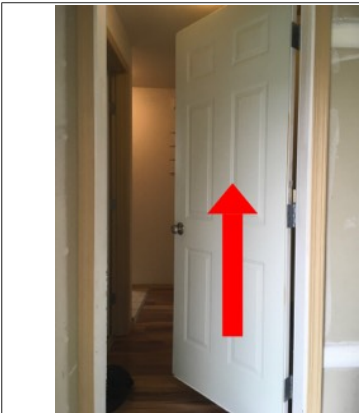
The garage door does not automatically/properly close. This could be a SAFETY ISSUE and should be evaluated/repared by licensed contractor.

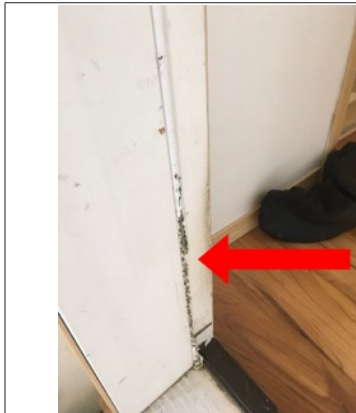
Damaged weatherstripping on garage door (into house). Recommend further evaluation/repair by licensed contractor.

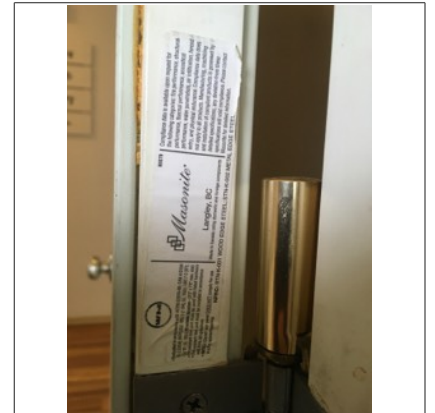
Image of manufacture's tag of the door into/exit from garage.

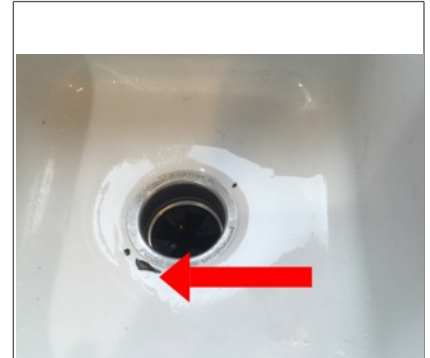
Sink surface has chips in finish. Recommend repair by licensed plumbing contractor.

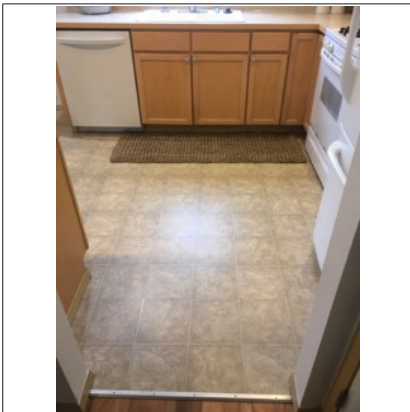
Image of kitchen floors.

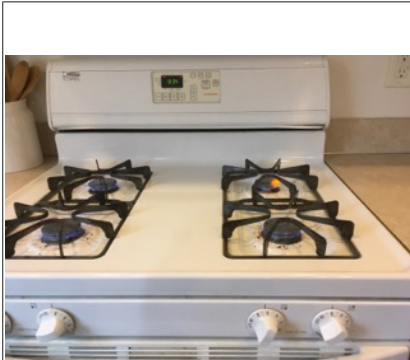
Image of gas stove. All burners operable.

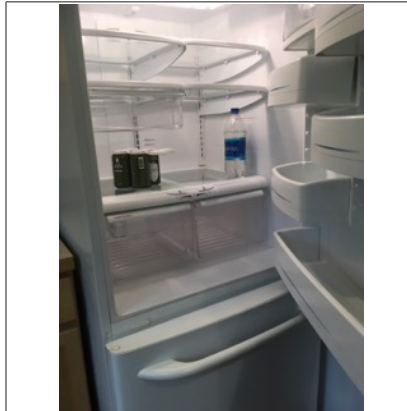
Image of interior of refrigerator.

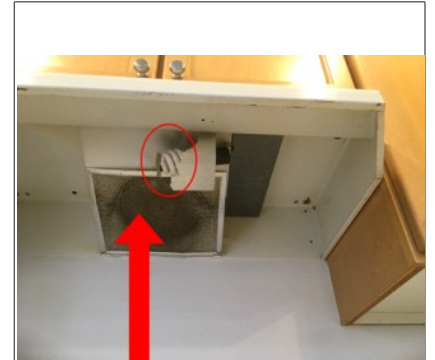
The light bulb cover on the kitchen hood is cracked/damaged. Recommend repair by licensed contractor. The exhaust filter is dirty and should be cleaned.

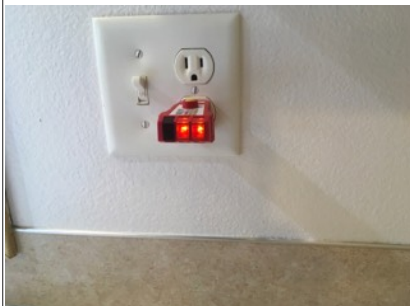
Image of tested GFCI outlet. The GFCI reset is located under the microwave shelf.

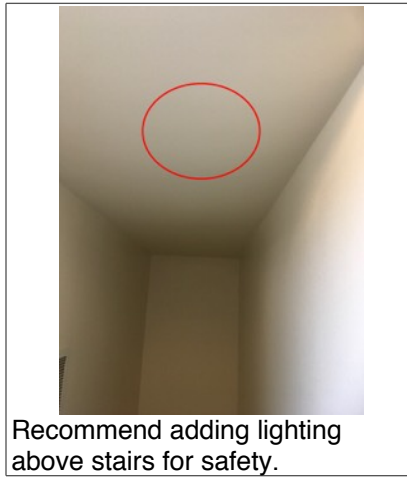
Recommend adding lighting above stairs for safety.

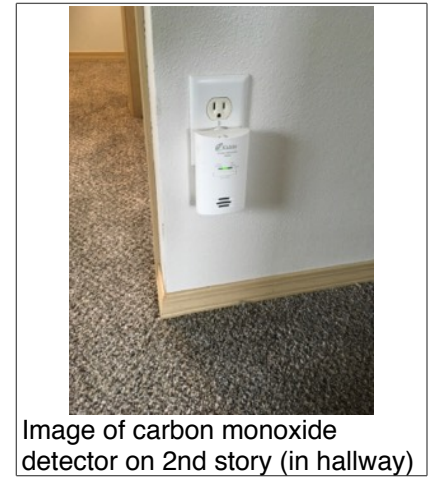
Image of carbon monoxide detector on 2nd story (in hallway)

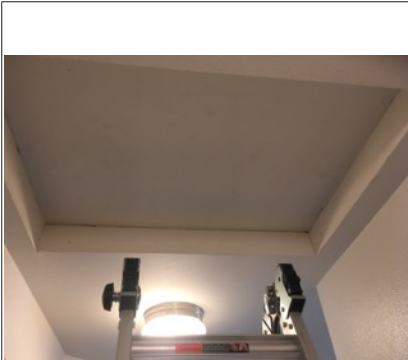
Image of attic hatch located next to laundry room.

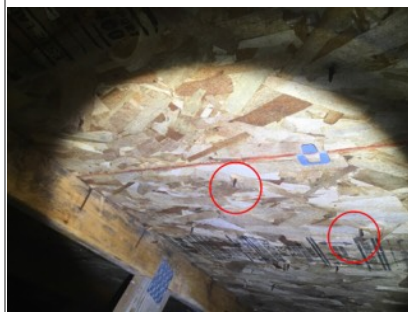
Roofing nails slightly rusty inside attic. Recommend further monitoring for possible issues with ventilation.

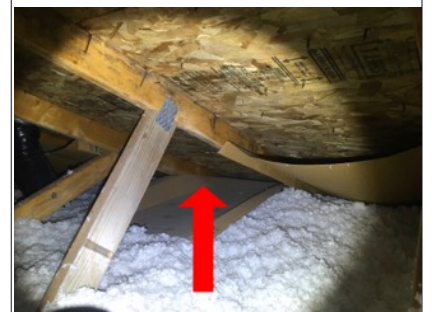
Several insulation baffles have come loose from the trusses. Recommend reattaching baffles to roof trusses.

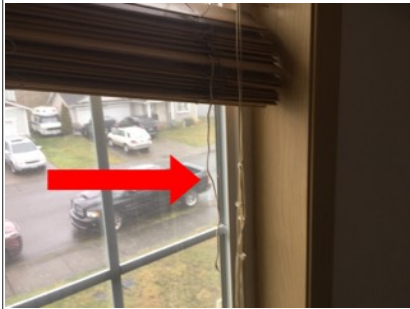
Image of damaged cord on master bedroom blinds.

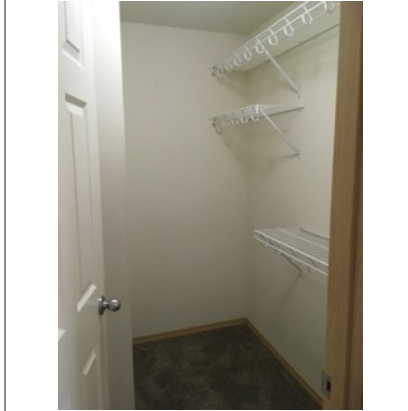
Image of master bedroom walk-in closet.

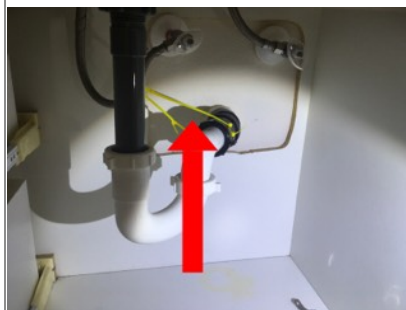
Image of plumbing under sink. Improper use of zip tie for plumbing support. Recommend replacement.

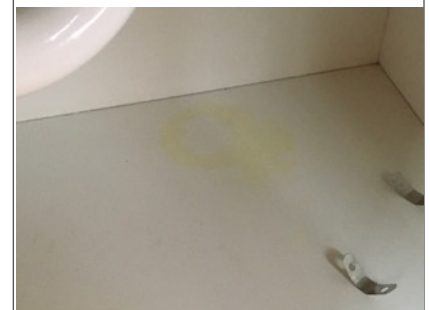
Image of stain under sink.

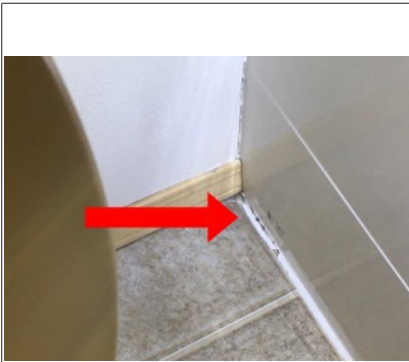
Missing caulking around bottom of shower/tub to prevent water intrusion into flooring.

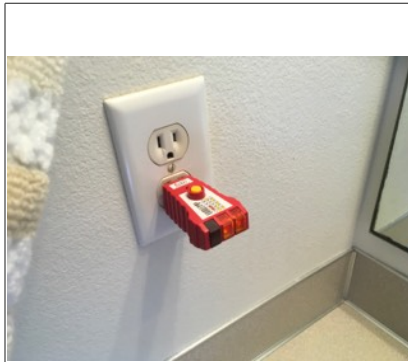
Image of testing of electrical receptacle.

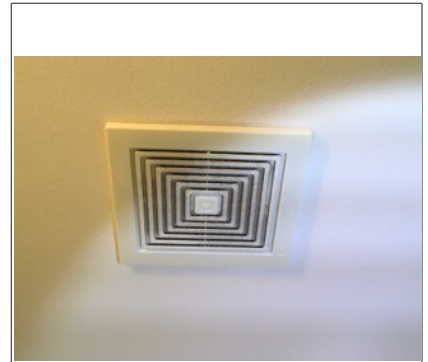
Image of exhaust fan. Recommend cleaning to allow proper airflow.

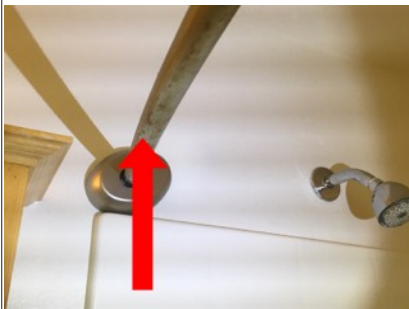
Rust evident on shower curtain rod.

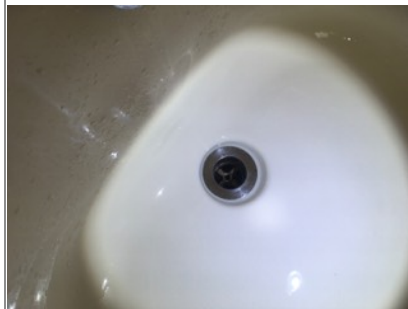
The tub stopper is missing and should be replaced.

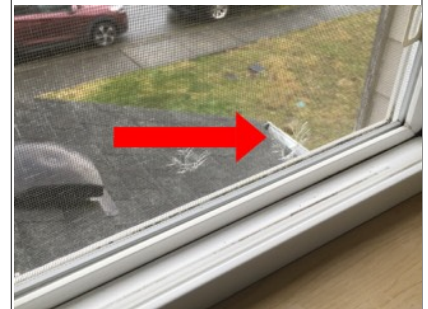
Damaged window screen

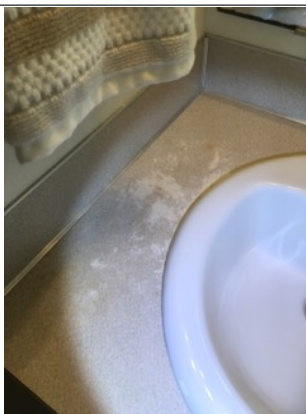
Image of stains on countertop surface

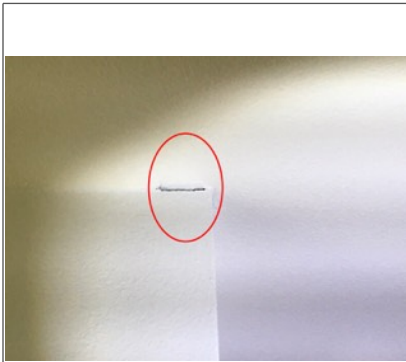
Crack along wall/ceiling seem above closet door. Recommend further monitoring.

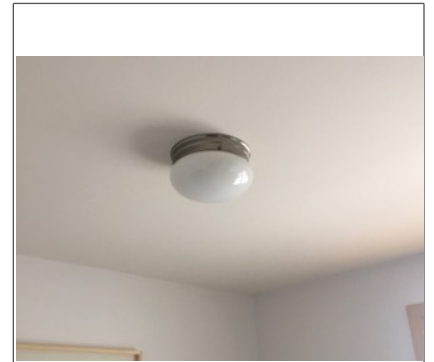
Image of light in bedroom. Light was not operational when I inspected this room, but later was found to be working.

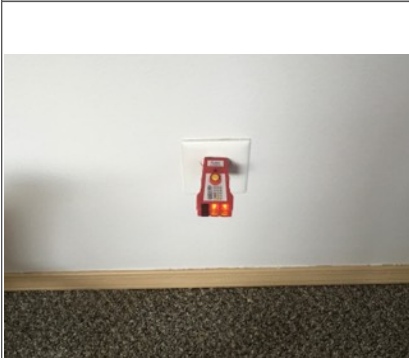
Image of tested electrical outlet in bedroom

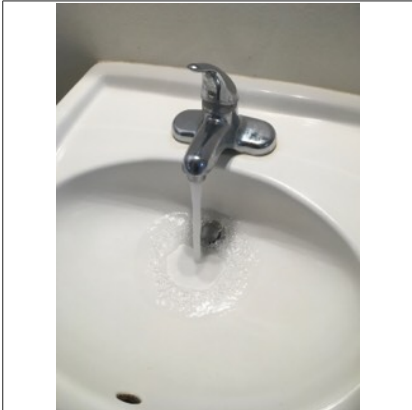
Image of running water in sink

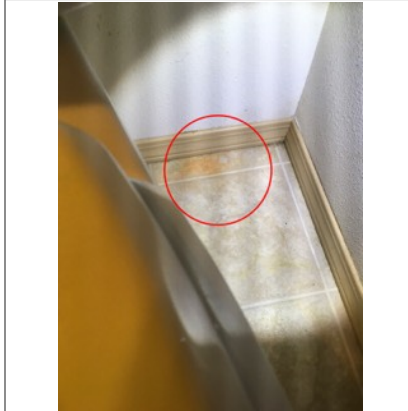
Image of stains on floor. No active water leak present.

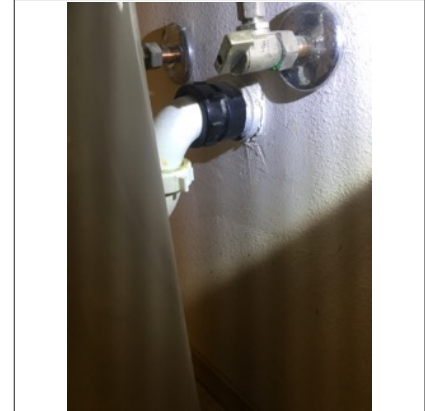
Image of plumbing behind sink

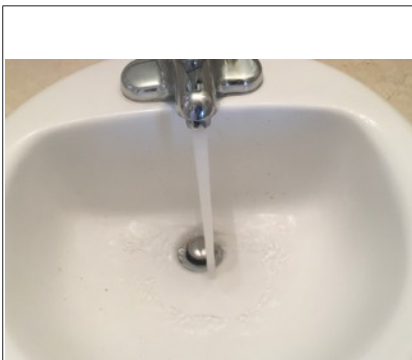
Image of water flow in sink.

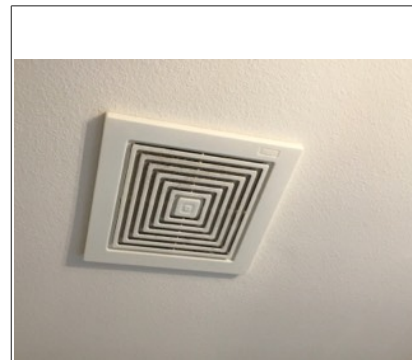
Image of exhaust fan. Recommend cleaning for better airflow.

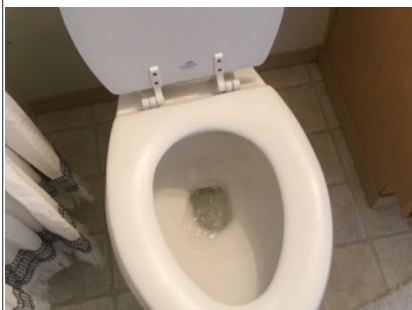
Image of functioning toilet.

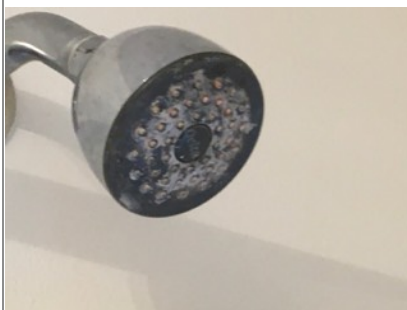
Image of build-up on shower head. Recommend cleaning/replacement if necessary.

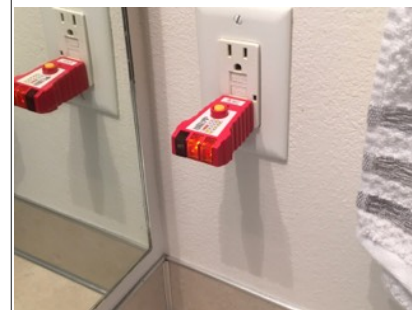
Image of tested GCFI outlet in second bathroom. This GCFI outlet controls all three bathroom receptacles.

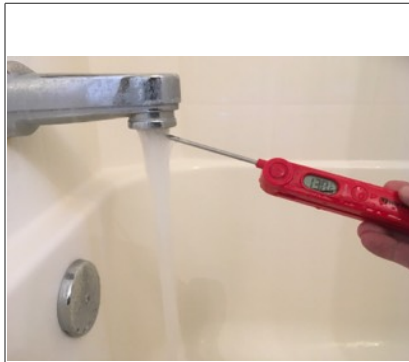
Water is 130 degrees out of 2nd bathroom tub. This could be a SAFETY ISSUE and recommend adjustment of temperature setting on hot water tank. If temperature cannot be adjusted properly I would recommend further evaluation/repair by licensed plumbing contractor.

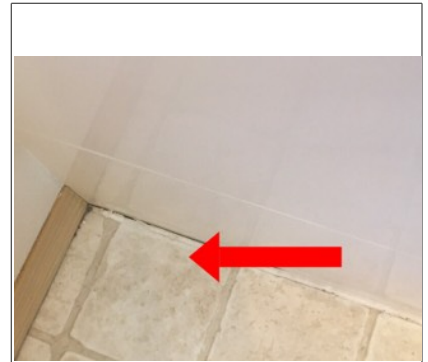
Missing caulking around bottom of shower/tub to prevent water intrusion into flooring.

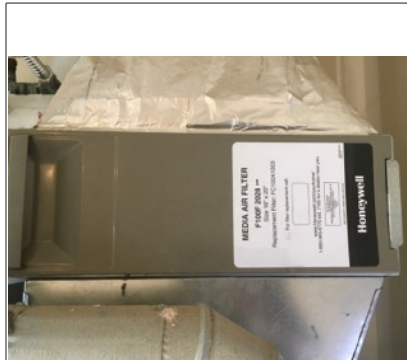
Image of filter door on HVAC unit. Recommend replacement of filters at regular intervals.

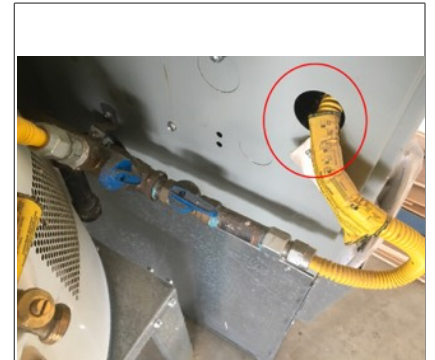
Flexible appliances connectors should not enter appliance cabinet. This could be a SAFETY ISSUE and recommend further evaluation/repair by licensed plumbing contractor.

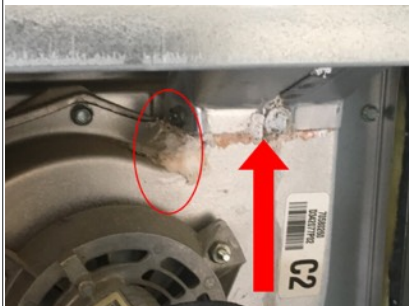
There appears to be mineral residue next to the draft inside HVAC unit. Recommend further evaluation by licensed HVAC contractor.

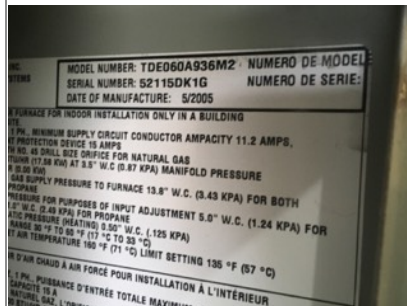
Data plate for HVAC.

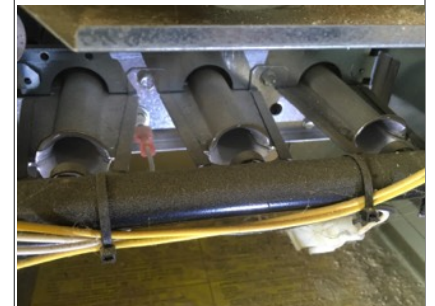
Image of burner ports on HVAC unit

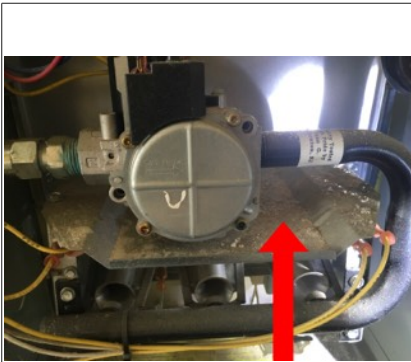
There is residue/build-up inside HVAC unit. Recommend further evaluation by licensed HVAC contractor.

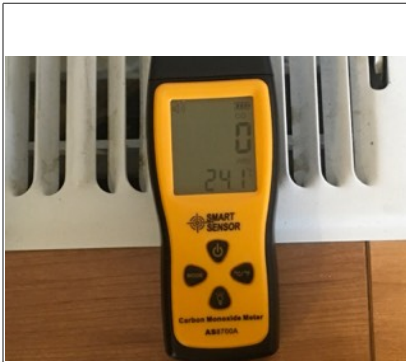
No carbon monoxide detected on HVAC register inside house.

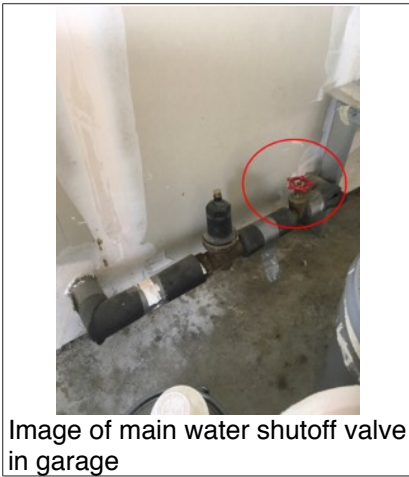
Image of main water shutoff valve in garage

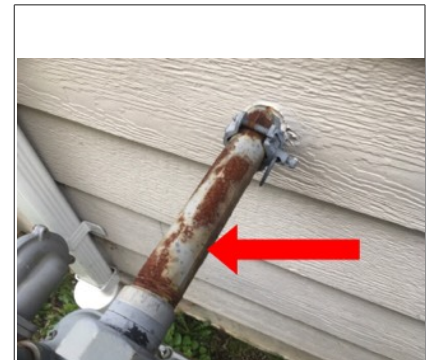
Image of rust on gas pipe entering building. Recommend further evaluation by licensed plumbing contractor.

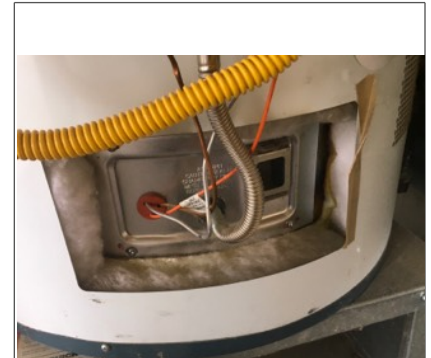
Image of interior of hot water tank- burner area.

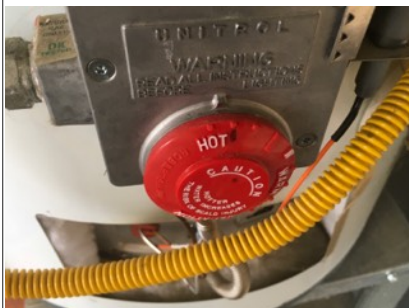
Image of temperature setting (on HOT).

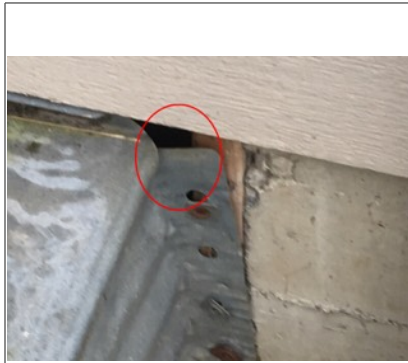
Recommend sealing gap to prevent rodent access to crawlspace.

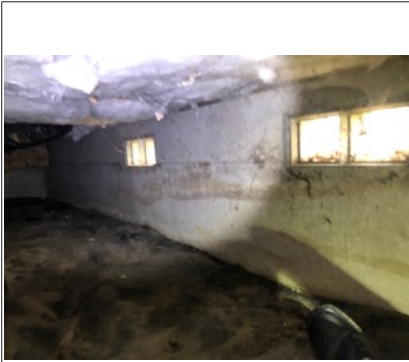
Image of poured concrete foundation walls

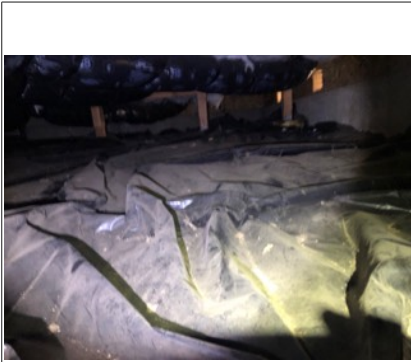
Image of vapor retarder on top of gravel floor

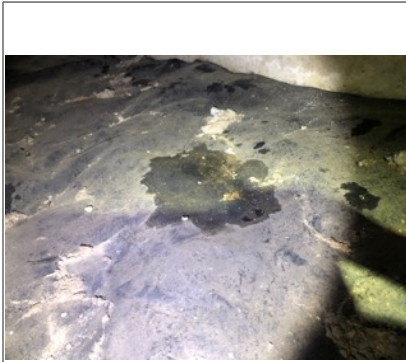
There are several spots on vapor retarder that has evidence of water accumulation in the past. I could not find evidence of active water leak.

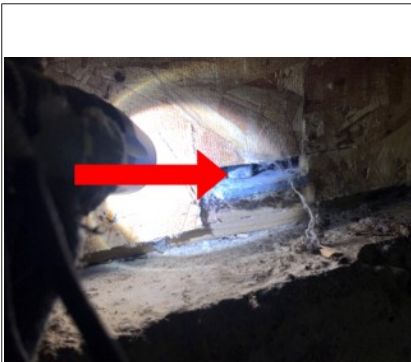
Image of seismic plate and bolt.

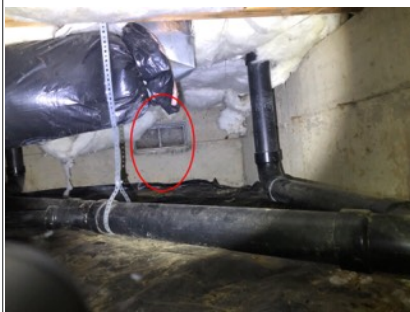
Crawl space ventilation covered/sealed on northeast corner of building. Recommend further evaluation by licensed contractor.

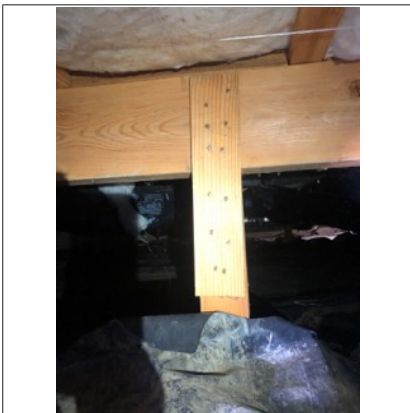
Image of beams/columns in crawl space.

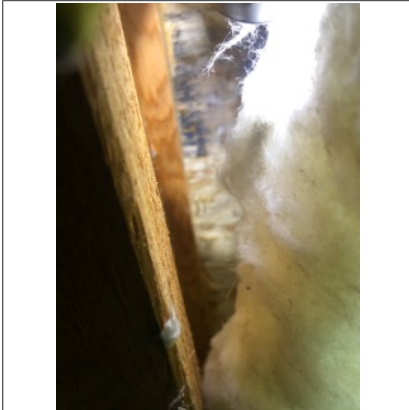
There are several spots below kitchen that insulation is not properly installed against the subfloor. Recommend further evaluation/repair by licensed contractor.

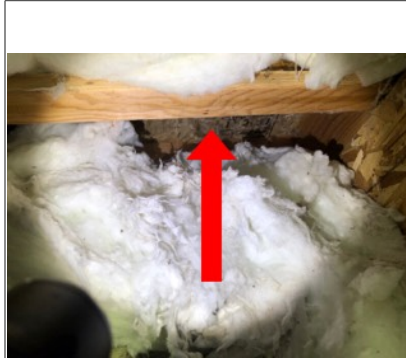
On northeast corner of crawl space insulation is not properly installed against the subfloor. Recommend further evaluation/repair by licensed contractor.

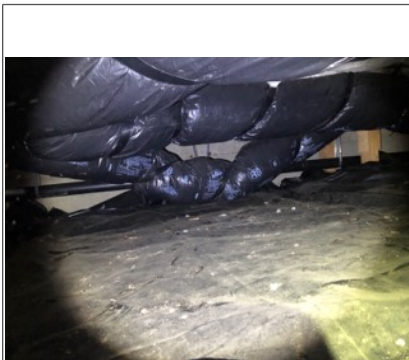
Image of vapor retarder.
