Home Inspection Report

Address Not Available, Lynnwood, Washington 98087

Wednesday, December 30, 2020

1230202001

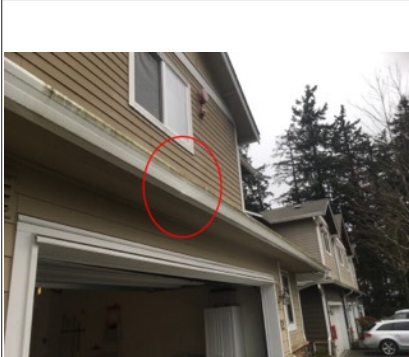
Small dent on front gutter system. This does not effect the functionality of the drainage system.

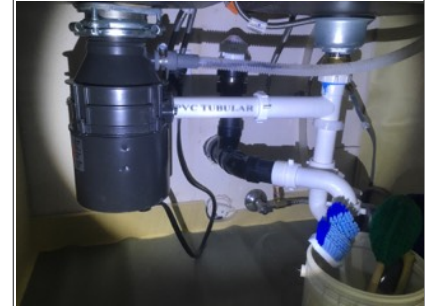
View of plumbing under kitchen sink

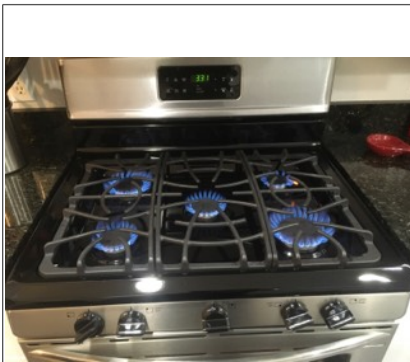
View of range with all burners functional.

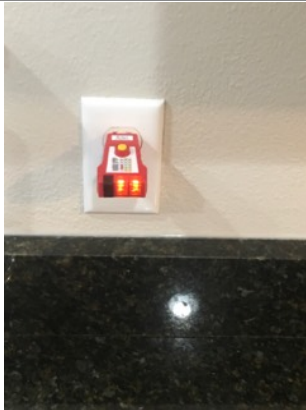
View of GCFI receptacle in the kitchen

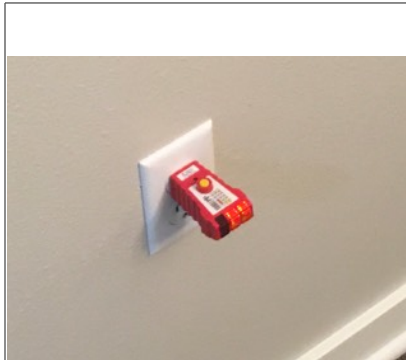
View of tested receptacle in dining room.

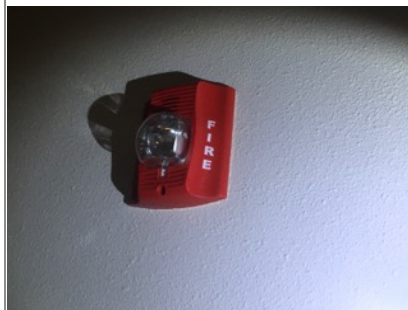
Image of fire alarm. Not inspected or tested-out of scope of home inspection.

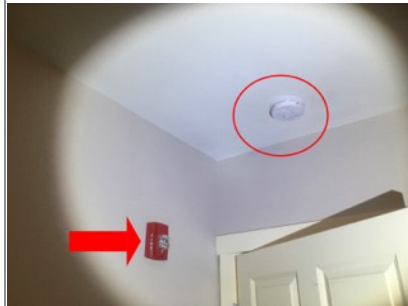
Image of smoke detector in circle in left bedroom. Arrow points to fire alarm that is not tested or inspected and out of scope of home inspection.

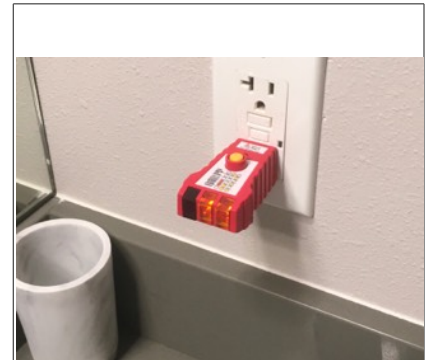
Image of tested GCFI receptacle in bathroom. This GCFI outlet is upstream of both first story bathrooms.
