Home Inspection Report

Address Not Available, Lynnwood, Washington 98087

Wednesday, December 30, 2020

1230202001

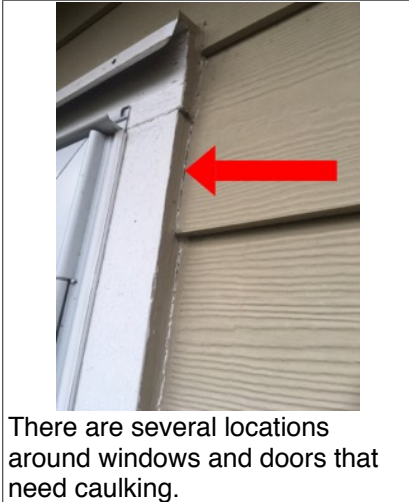
- Condition** Marginal Recommend around windows/doors/masonry ledges/corners/utility penetrations
Photos

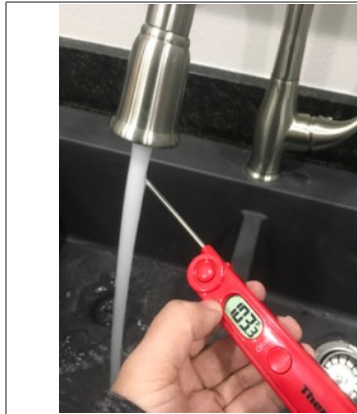
Hot water tested at 103°

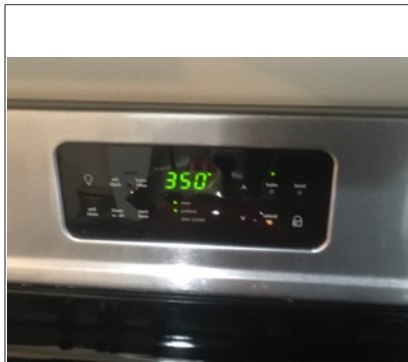
View of oven at 350°

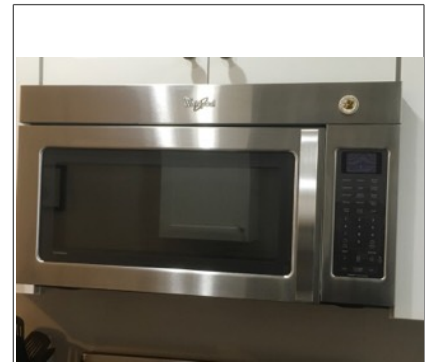
View of microwave and vent being tested.

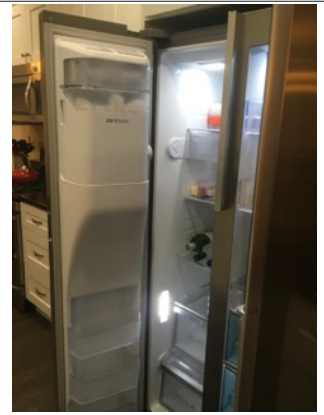
View of refrigerator interior.

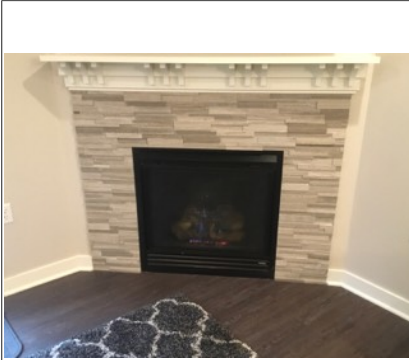
View of fireplace in the living room
